## ENGINEERING DIVISION

### EMERGENCY FIELD OBSERVATION 03 September 2020

**Project:** Sinkhole and Associated Collapse at Berth 44 Main Building

**Structure:** Main Building  
Berths 44 former San Pedro Boatworks

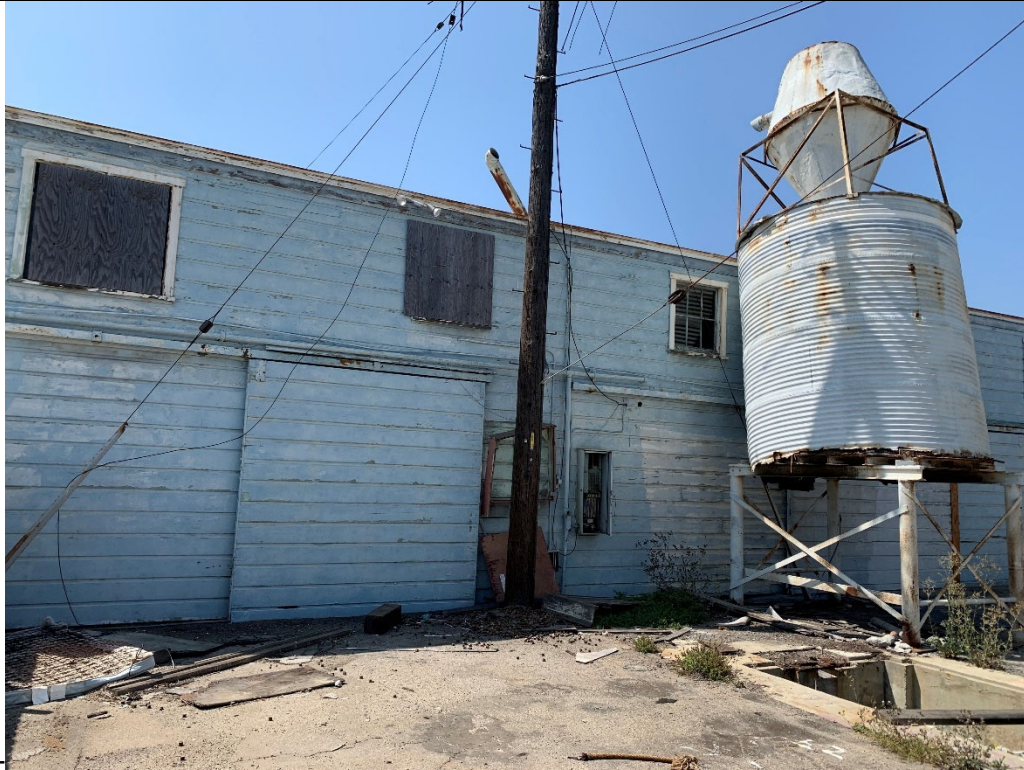
**P-1 (Exterior – North Side Lumber Shed)**

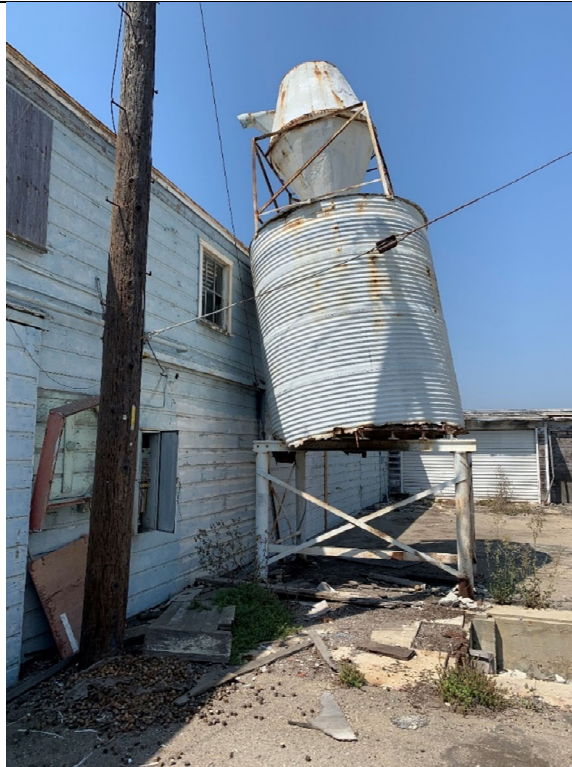
**P-2 (Exterior – N Side Lumber Shed, E Side Original Bldg, Silo)**

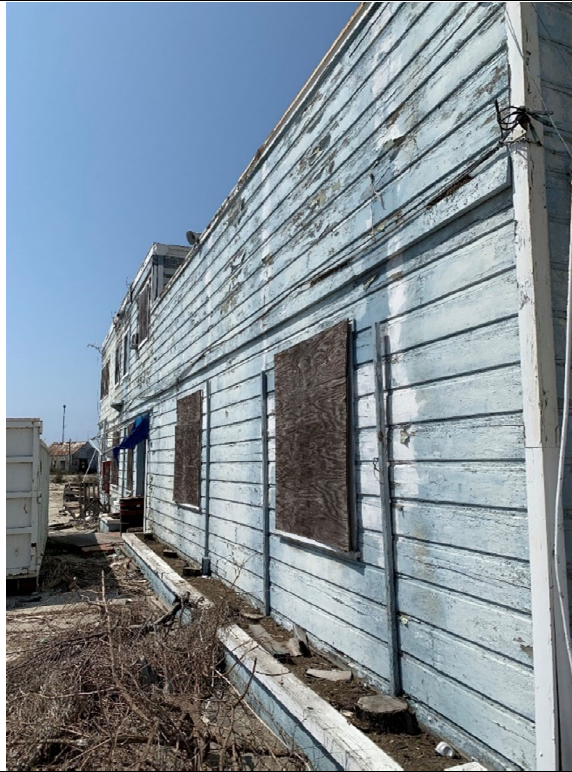
**P-3 (Exterior – East Side Lumber Shed, Office/Shop)**

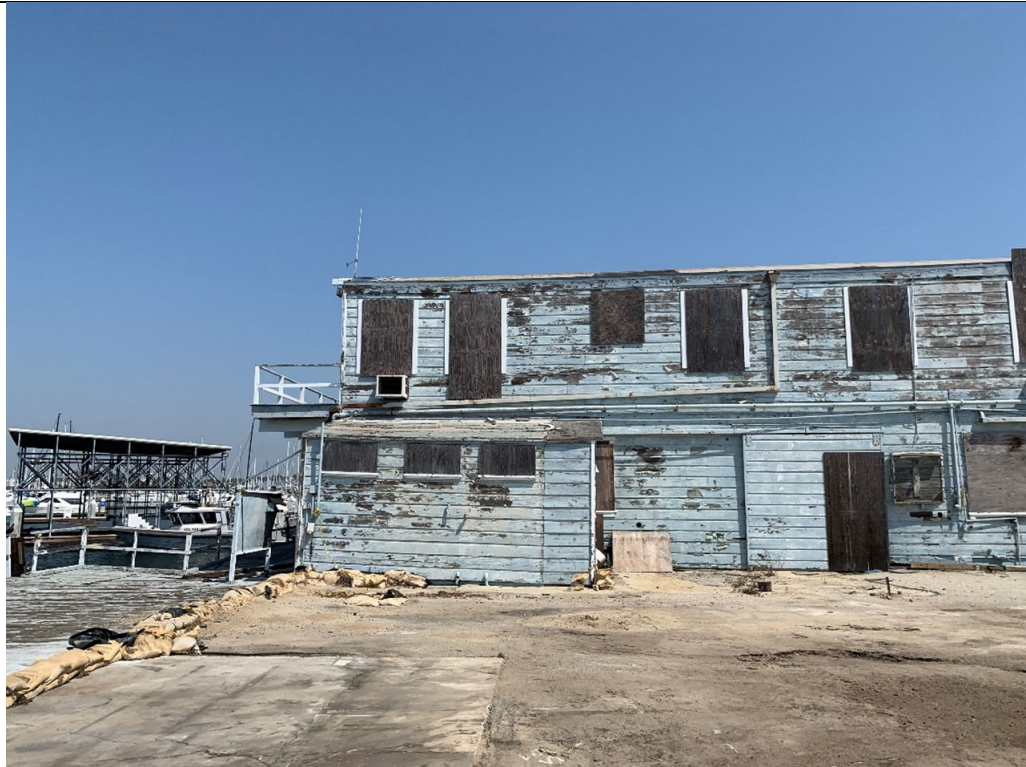
**P-4 (Exterior – South Side)**

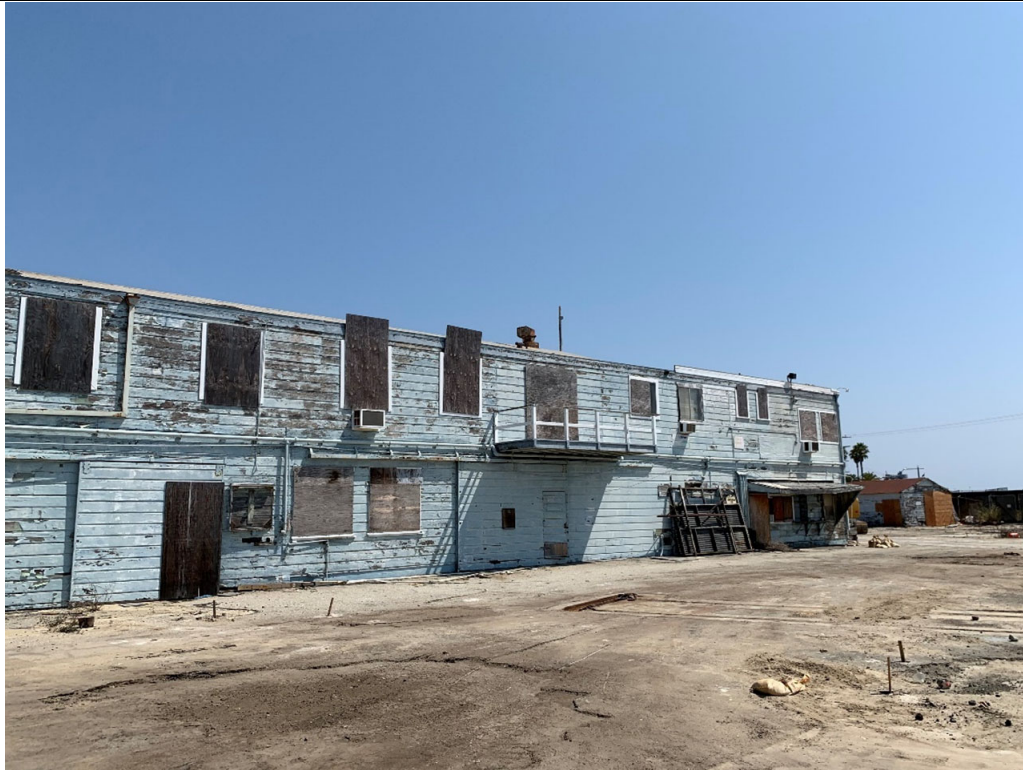
**P-5 (Exterior – South Side)**

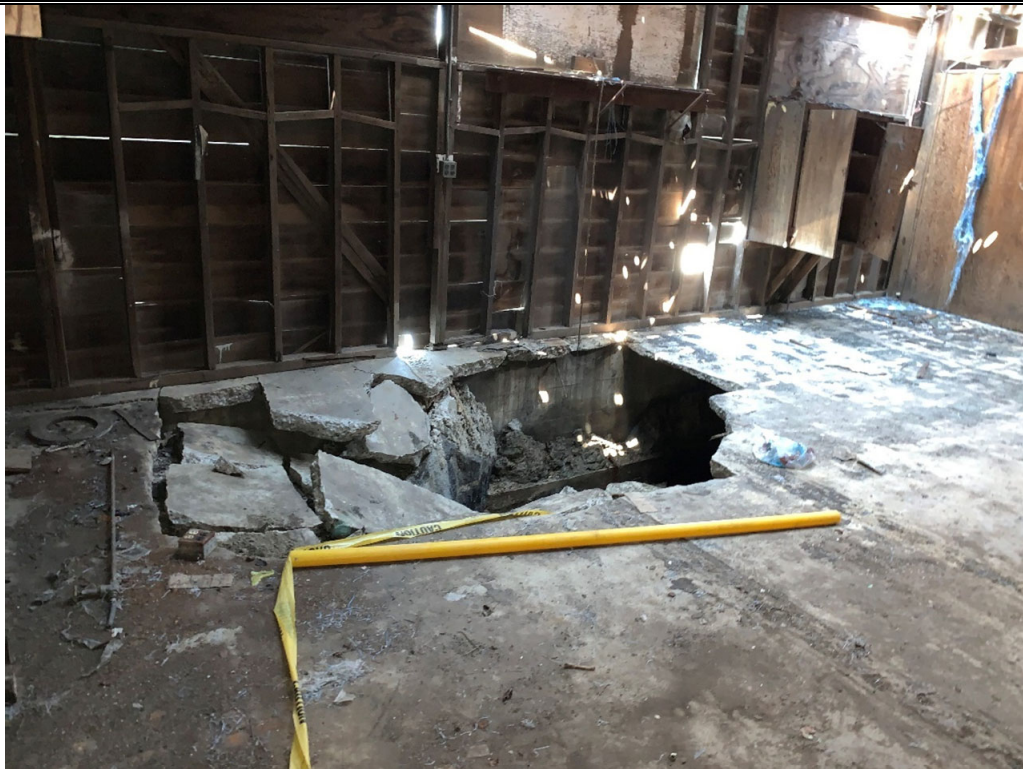
In the northern portion of the building, a large sinkhole has developed behind the seawall (upon which the west wall of the building is built). An approximately 5-foot by 9-foot portion floor slab on grade has collapsed into the hole, and it is evident that the void continues beyond the area of the floor collapse. It was impossible to determine the southerly extend of the void under the remainder of the building, but differential settlement of concrete slabs immediately south of the building indicate the possible presence of a second sinkhole void or continuation of the first. The sinkhole will continue to grow along and away from the seawall, at some point resulting in collapse of the building, until it is filled with cementitious grout to prevent further loss of soil. The larger or more numerous the sinkholes are, the sooner collapse will occur.

**P-6 (Interior – Orig Bldg, West Wall, Floor, Sinkhole)**

Repair of sinkholes involves removing pavement or slabs over the suspected void and excavating to ensure that the full extent of the void is found. The voids can extend a considerable distance from where the sinkhole is originally observed. After excavation, the void is filled with a cementitious slurry to protect against future loss of material and the pavement or slab is reconstructed.

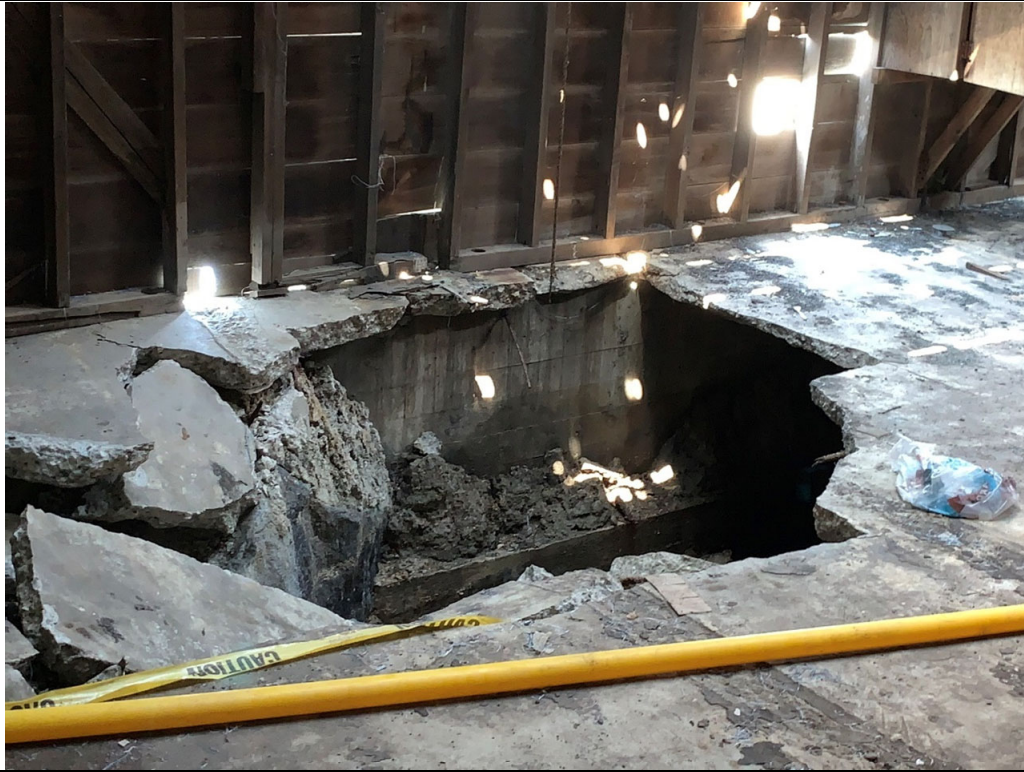
Sinkholes of this nature have occurred in other areas of the Port, adjacent to older seawalls or rock dikes. They are typically caused by tidal action over many years, with the ebb and flow of the tide percolating through the rock dikes and removing fine soil particles and eventually creating a significant void. As in the case of the Berth 44 Main Building, the sinkholes often go undetected under a concrete slab or asphalt paving until sudden collapse occurs. In cargo terminals this has resulted in large container handling machines falling into sinkholes. Flexible asphalt paving will sometimes exhibit a depression as a warning of a pending sinkhole, but rigid concrete slabs tend to fail suddenly and without warning. Current seawall and dike design include filter fabric to reduce the loss of fines to tidal action.

**P-7 (Interior – Sinkhole, Seawall Visible)**

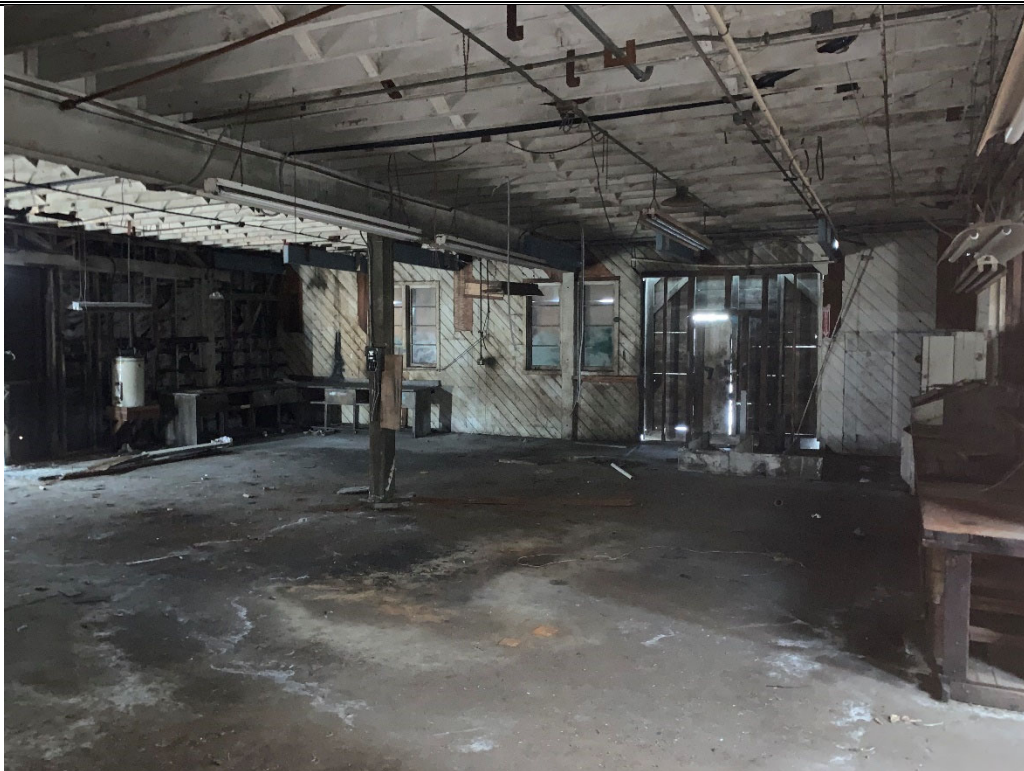
**P-8 (Interior – Machine Shop, South and West Wall)**

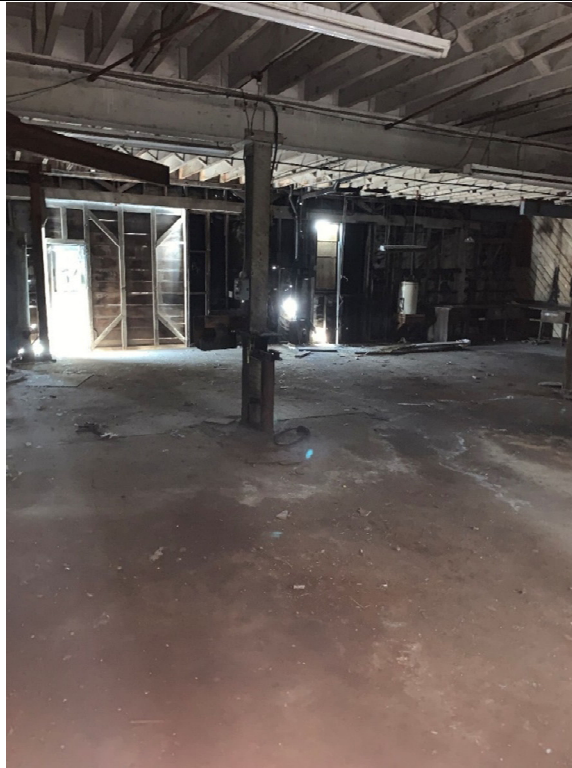
**P-9 (Interior – Wood Shop Floor and South Wall)**

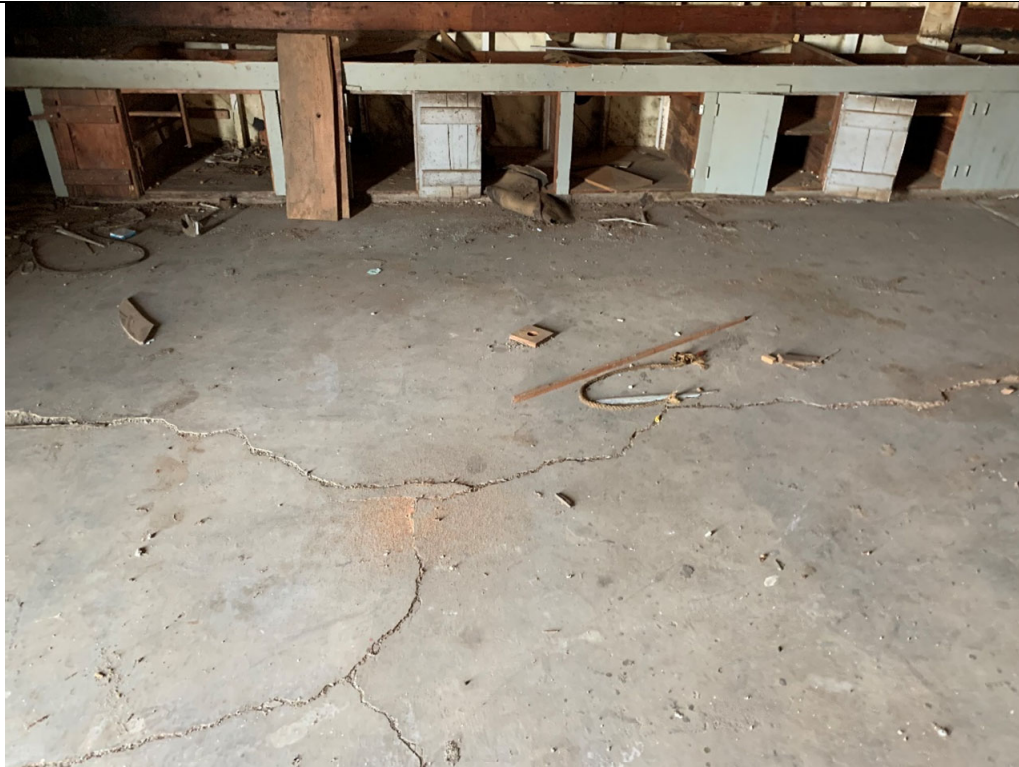
**P-10 (Interior – Wood Shop Floor and Partition Wall w/ Machine Shop)**

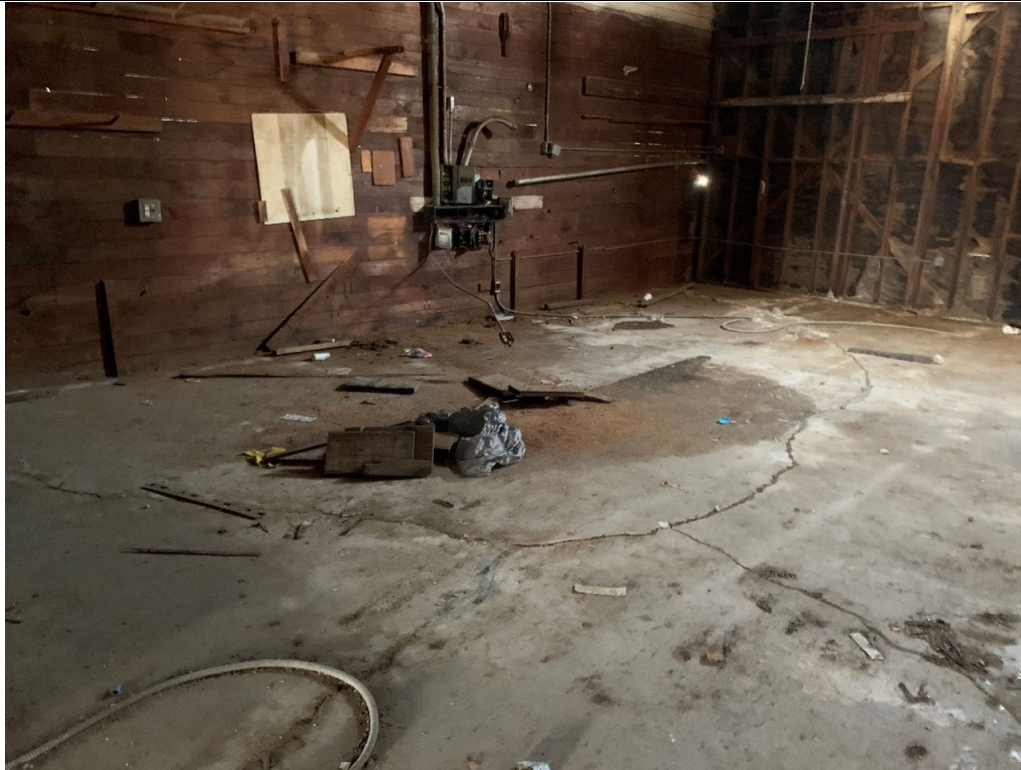
**P-11 (Interior – Wood Shop Floor and Partition Wall w/ Public Counter)**

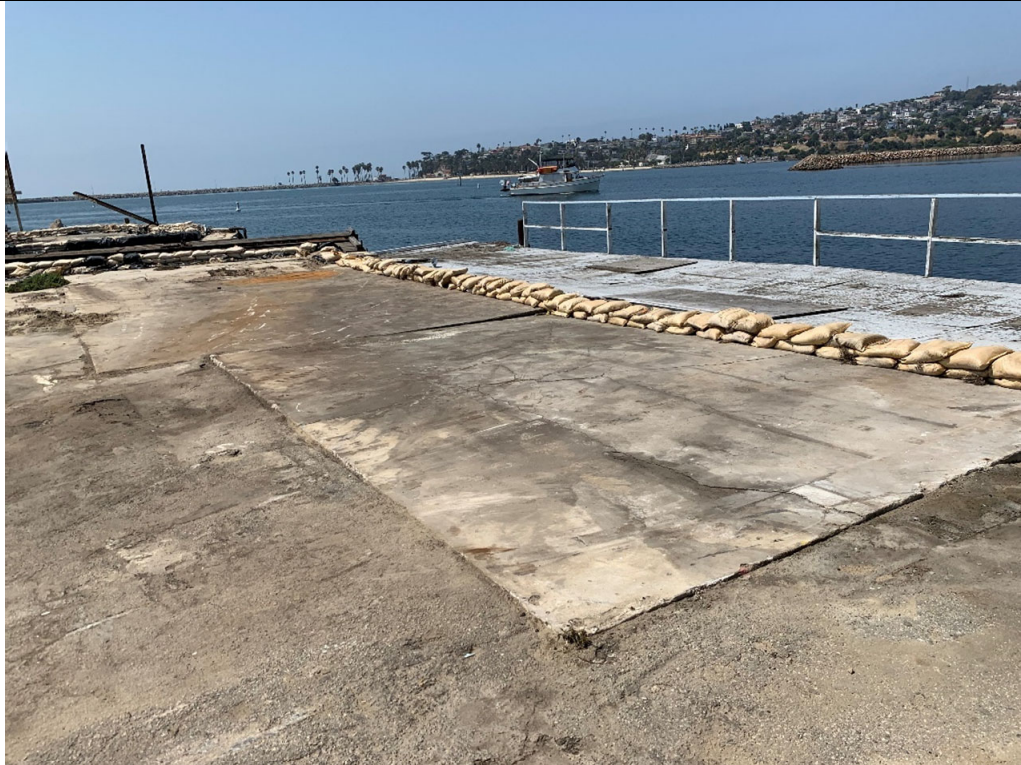
**P-12 (Exterior – Conc Slabs along Seawall Directly South of Bldg)**
