# LANDSCAPE INVENTORY

### Landscape Inventory for the San Pedro Waterfront Project

## Landscape Inventory San Pedro Waterfront Project

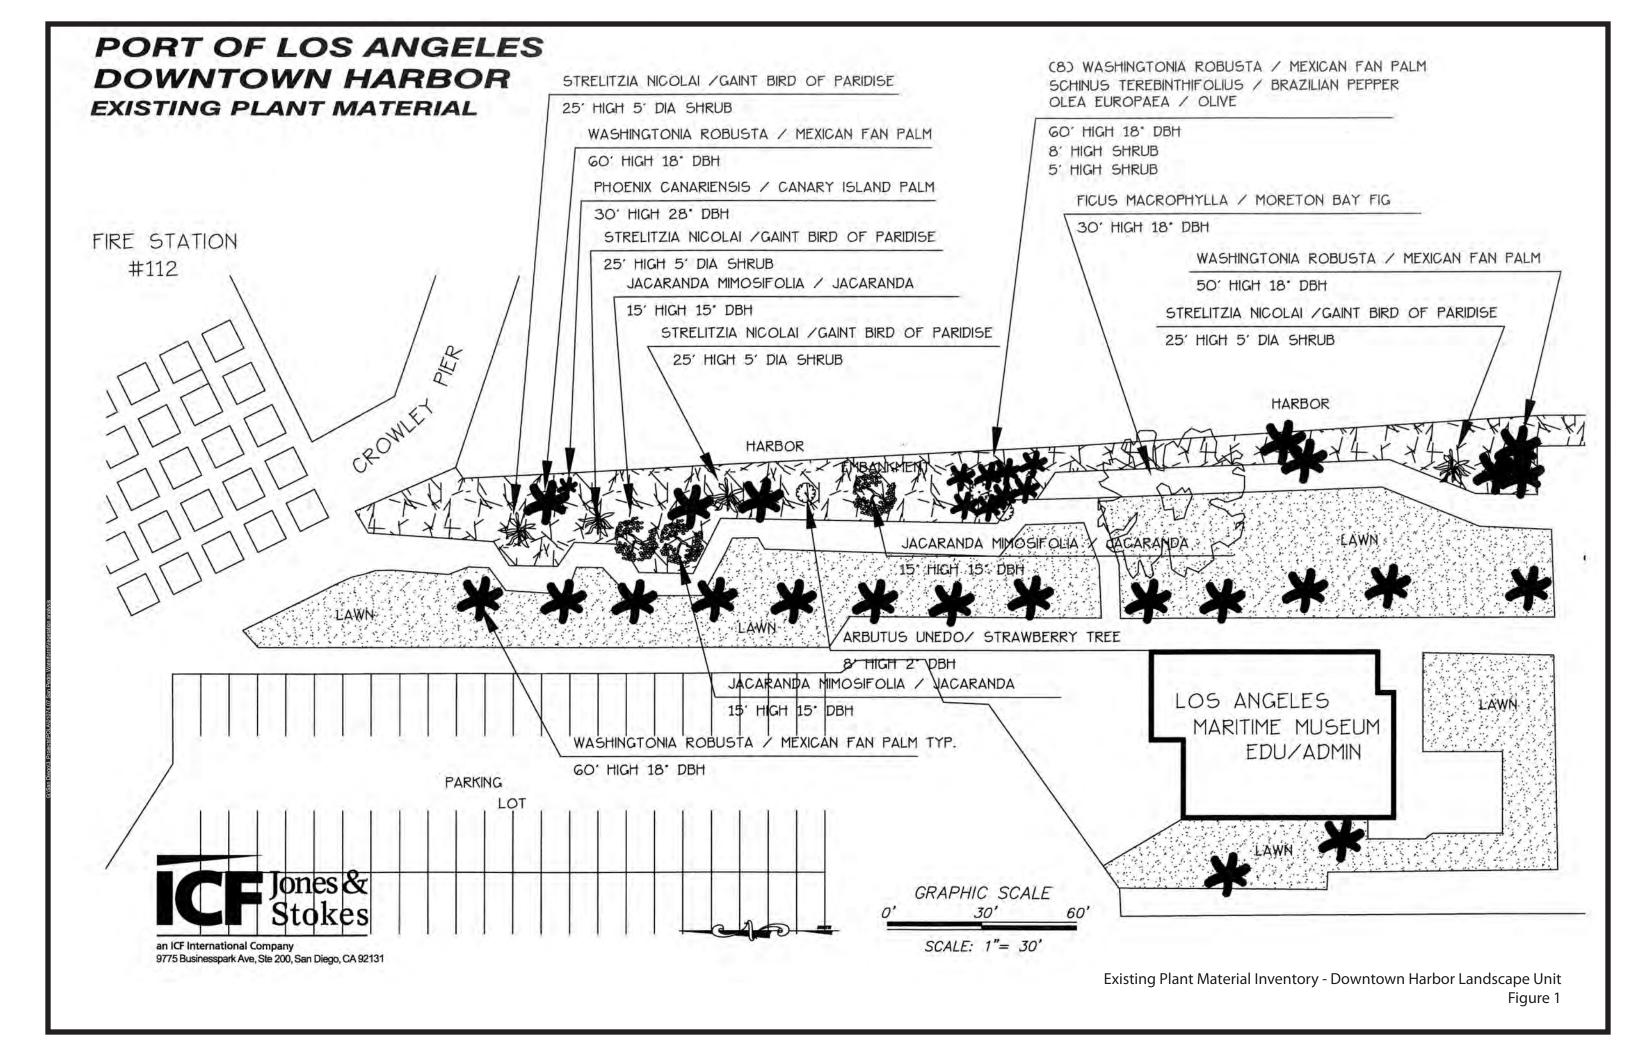
Figure 1 is a map showing the inventory of existing plant materials for the Downtown Harbor area. The map shows the species and common names, spatial distribution, height, and diameter of the vegetation. The most prolific species are 35 Mexican fan palms, which range from 30 feet to more than 60 feet tall. A row of the larger specimens spaced at 25-foot intervals parallels the east edge of the harbor parking lot. A large fig tree is located in the lawn area north of the Maritime Museum. The majority of the specimens are concentrated in a waterfront area near the Crowley Pier. This area also features the greatest diversification of plant materials including Mexican fan palms, Canary Island palms, giant bird of paradise, and two jacaranda trees. Overall, the trees are relative healthy but as these specimens have matured, they have become crowded. The jacarandas' foliage is pale and the bark on the trunks is damaged, which has compromised the integrity of the tree; it is possible that their root systems have been compromised by crowding, compaction, and the surrounding impervious concrete walkways.

While the current landscaping contributes to the ambience in certain areas of the existing waterfront, the specimens individually are neither historically or visually significant to the area and their value does not constitute relocating and transplanting.

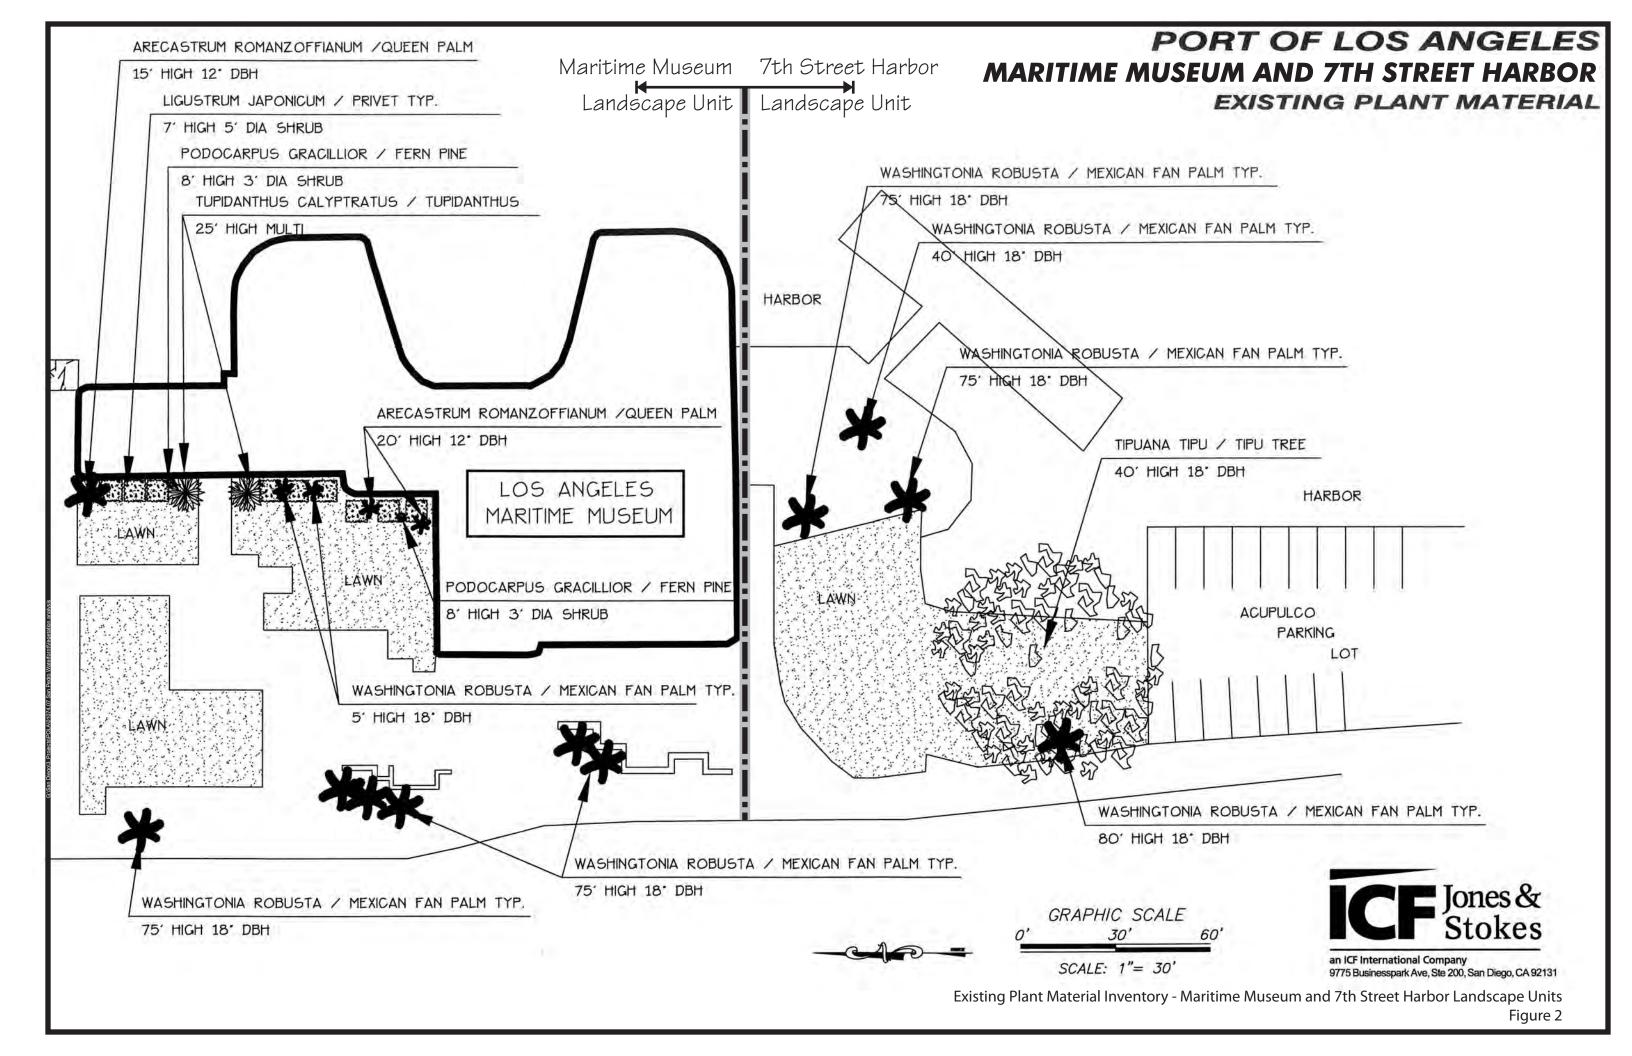
Figure 2 identifies the locations, size, and height of the existing landscape material in the 7th Street Harbor Landscape Unit. This landscape unit is a small, predominantly lawn area south of the Maritime Museum and north of the water cut (Berth 83) adjacent to the Acapulco Restaurant parking lot. There are four Mexican fan palms ranging from 40 to 80 feet tall. The southwest corner of this unit is dominated by a 40-foot-tall tipu tree. Photograph 6 is a view to the southeast toward the 7th Street Landscape Unit and illustrates the existing landscape conditions.

The 7th Street Harbor Landscape Unit contains five large, mature specimens that have grown very tall and consequently, have become out of scale with the surroundings. None of these specimens are unique or visually significant. The conclusion of the evaluation for this landscape unit is that none of these aging specimens adds significantly to the visual character of the area and consequently, do not warrant transplanting.

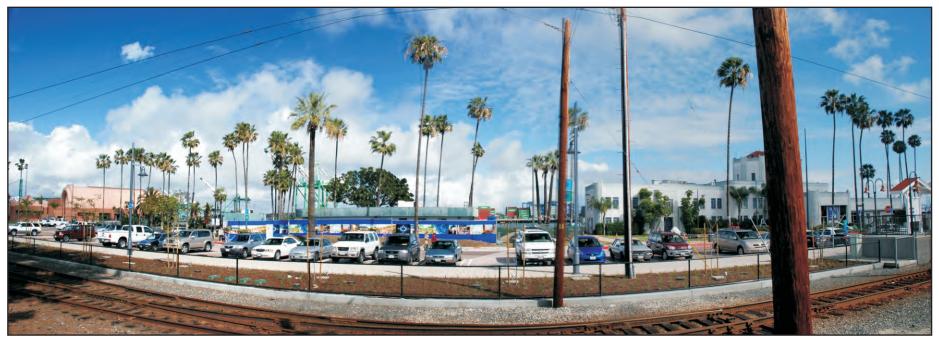
Photograph 1 is a panoramic photograph of the proposed Downtown Harbor cut area. This 150° perspective view shows Fire Station #112 to the north (left) and the Maritime Museum building to the south (right), and provides an overview of the site. The new landscaping and paving east of the Red Car Line in the photograph's immediate foreground is the extension of the existing promenade. Approximately 25 feet beyond that will be the Downtown Harbor. Photograph 2 is a view to the northeast of the diverse landscaping at the area near Crowley Pier. Photograph 3 is a photograph of the trunk of the southern jacaranda tree and compacted soil surrounding the vicinity.

Photo 1 - Panoramic photo of Downtown Harbor Landscape Unit. View direction Northeast - Southeast.

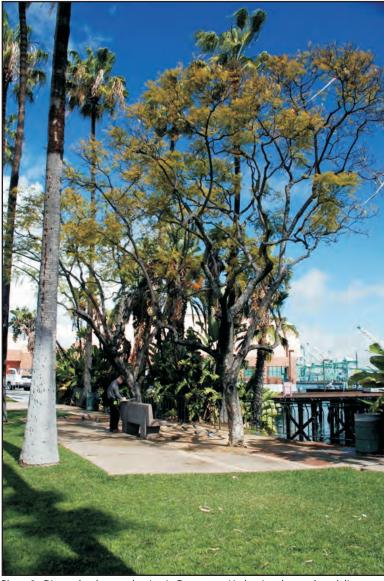
Photo 2 - Diverse landscape planting in Downtown Harbor Landscape Area Adjacent to Crowley's Pier and the Main Channel. View direction Northeast.

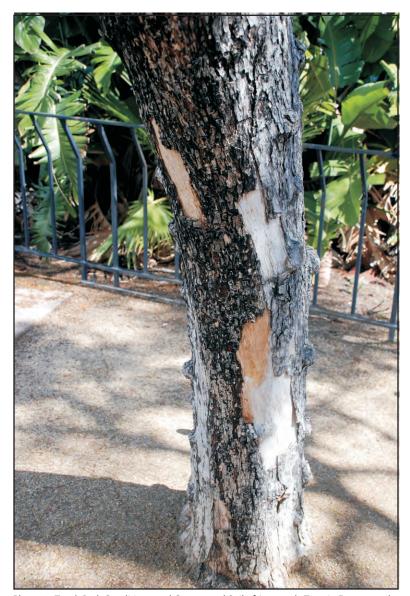
Photo 3 - Trunk Bark Conditions and Compacted Soil of Jacaranda Tree in Foreground of Photo 1

along Harbor Boulevard would need to be avoided or relocated during the transportation phase of the transplanting process. Most of these trees have grown tall and are out of scale for this long narrow waterfront parcel. The jacarandas are high maintenance and, because of their deteriorated condition, would not be good candidates for transplanting. The two large giant birds of paradise require a lot of room and water and are not a current component of the promenade's plant palette.

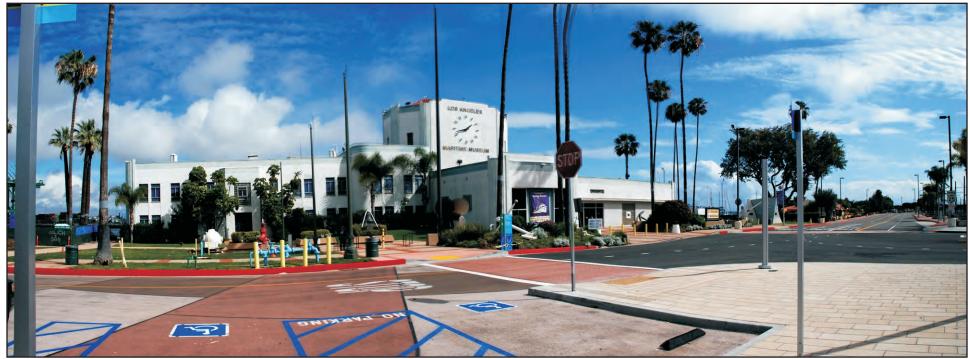
Figure 2 is a representation of the landscaping and shows the locations and sizes of the existing plant material that surround the Maritime Museum building. Photograph 4 is a panoramic view of the museum's west elevation and shows the existing conditions and specimens in the landscape unit. Six 60-foot tall Mexican fan palms frame the museum's entry. Several lawn areas surround the building and are interrupted by the extensive decorative paving, which also acts as foundation for the nautically-themed exhibits near the museum's main entrance. There are three raised planters in this area with manicured shrubs that include mock orange, dusty miller, and Indian hawthorne. The majority of the diversified landscaping in this unit is directly adjacent to the Maritime Museum building. Along the museum's north wing there are three queen palms, a series of fern pines and privets creating a hedge, and two short fan palms. Framing the museum's north entrance are two tupidanthus. Photograph 5 is a panoramic view of the museum's west elevation showing the existing landscape unit. All specimens in this area are healthy and viable.

Photo 4 - Panoramic photo of Maritime Museum Landscape Unit. View direction East - South.

None of the specimens within the Maritime Museum Landscape Unit are unique or a visually significant part of the landscape units viewshed or scenic character. Many of the specimens are in the later stages of their life cycles and appear out of scale in the confined waterfront area. Consequently, none of the specimens of this landscape unit warrant relocation or transplanting.

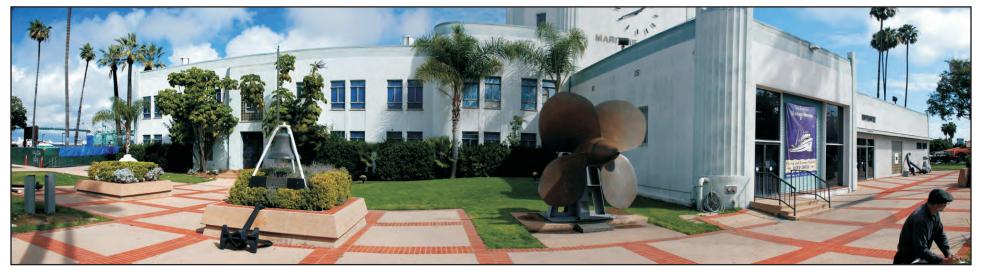
Photo 5- Panoramic photo of Maritime Museum Landscape Unit. View direction Northeast - Southeast.

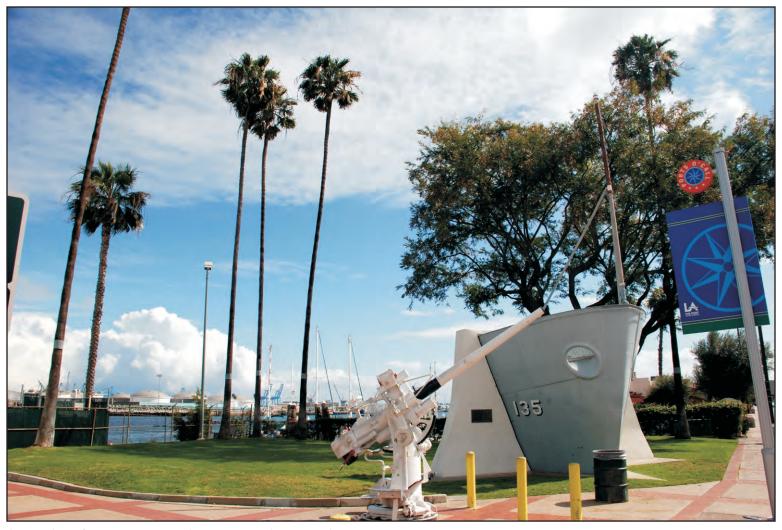
Photo 4 - Photo of Maritime Museum Landscape Unit. View direction Southeast.
