**Engineering Evaluation
Of
Gambol Marine Shipyard
Proposed Business Plan**

Supplement to July 21, 2010 Report

October 21, 2010

**The Port of Los Angeles
425 South Palos Verdes Street
San Pedro, CA 90731**

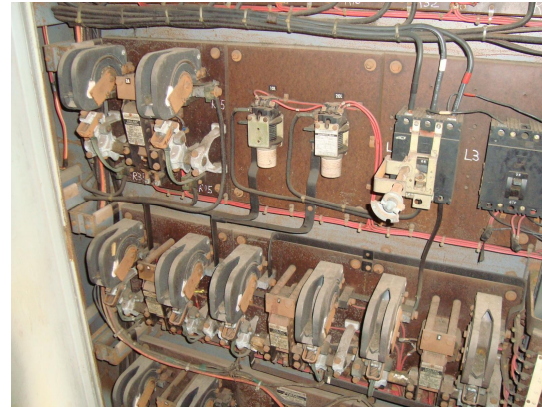
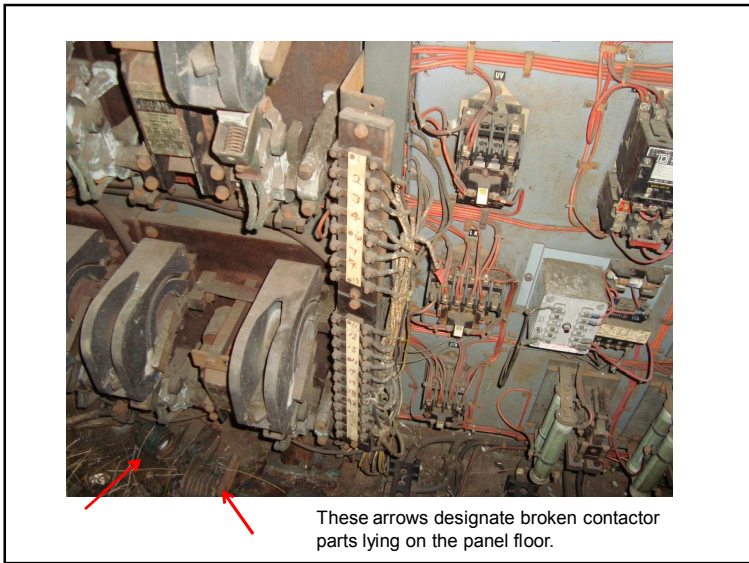
Electrical Panels for the Hoist, Boom Hoist, Swing and Gantry. The main concern of these panels is the functionality and lack of replacement parts.

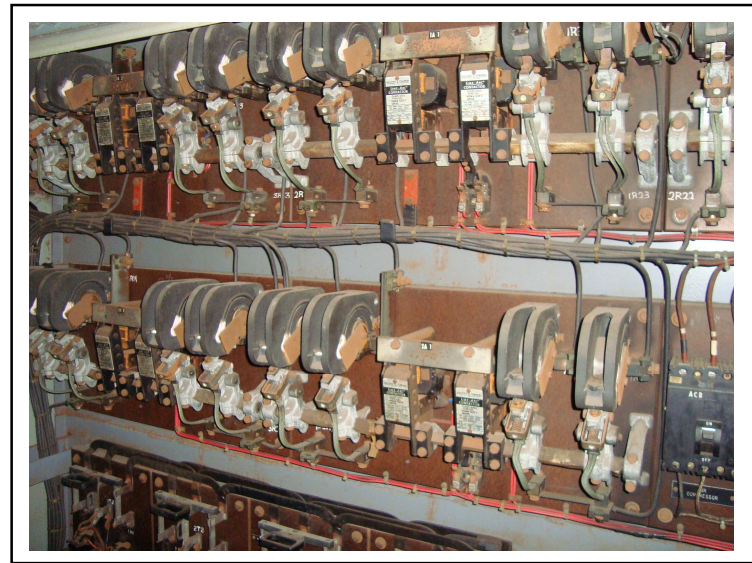
These arrows designate broken contactor parts lying on the panel floor.

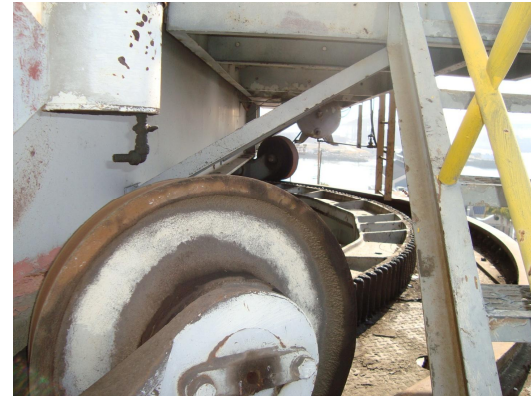
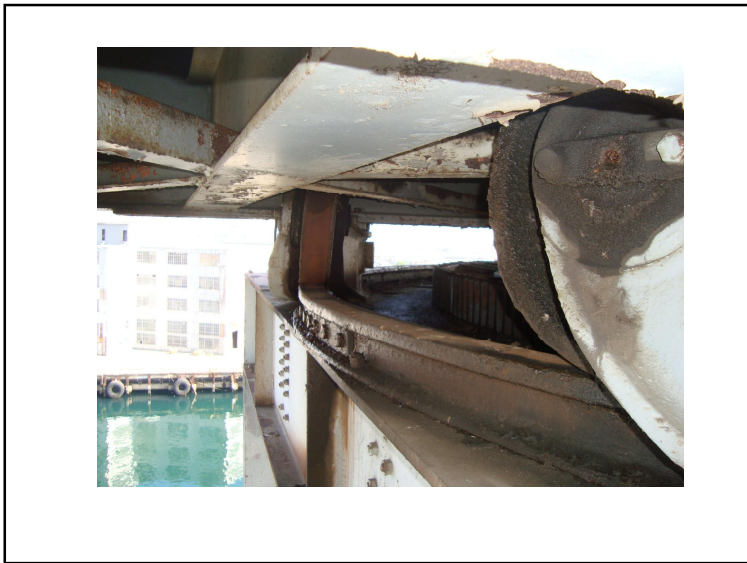
Rotator platform and wheels. The condition of these parts are unknown, but it is our feeling that this system would have to be reworked.

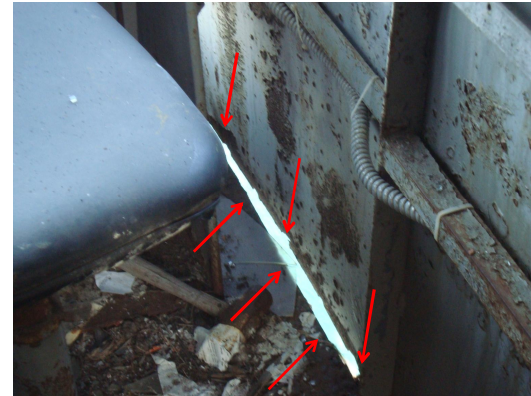
Our concern here is the structural integrity of the cab housing.
Light is visible into the cab.

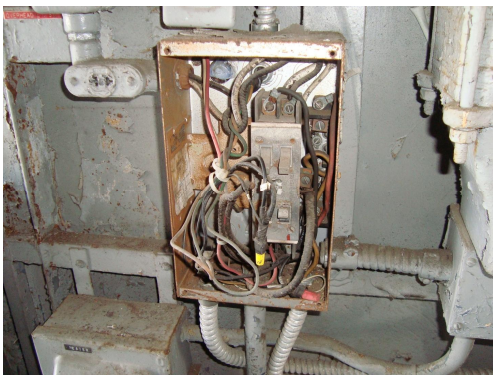
Please notice the aged and exposed wiring in the operator's cab and machinery house.

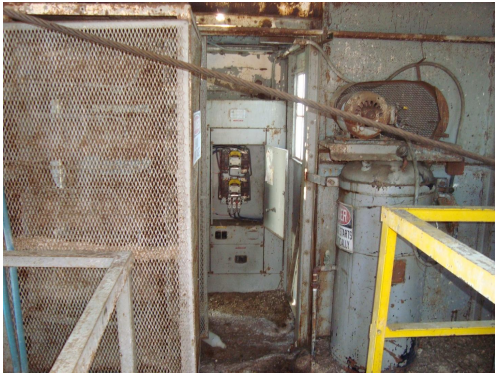
- Heavy de-lamination of structural steel (legs and cross-members)
- Extensive corrosion of floor plating
- Extensive corrosion of machinery house walls and roof
- Recommend decommissioning

Please notice the extensive rust corrosion. The structural integrity of all of the components is in question.

Non-destructive testing would need to be done prior to commencing on any/all rehabilitation project for six of the seven cranes. It is OTS's professional opinion that crane 4 be condemned and decommissioned due to its structural deterioration (exhibit A). Providing the remaining cranes pass the testing process, rust removal and painting would be necessary. This process would include the lead abatement or encapsulation that is in the existing paint.

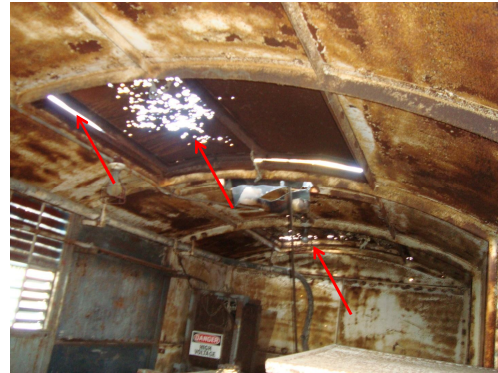
Severe deterioration of machinery house roof and walls. Light is shining through the roof in multiple locations.

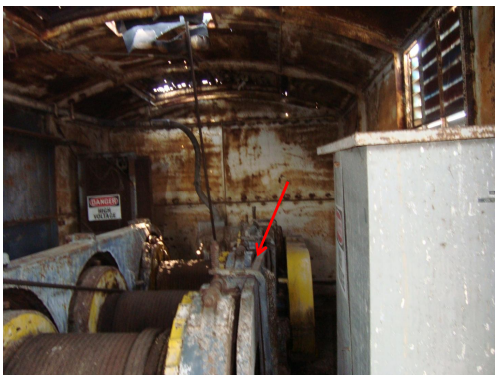
Notice the severe corrosion of critical components of the main hoist assembly.

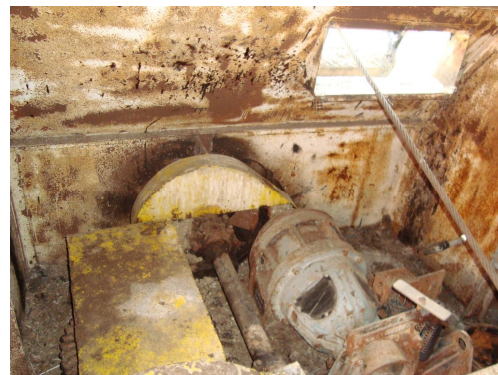
Rotator motor assembly completely covered in rust and bird droppings.

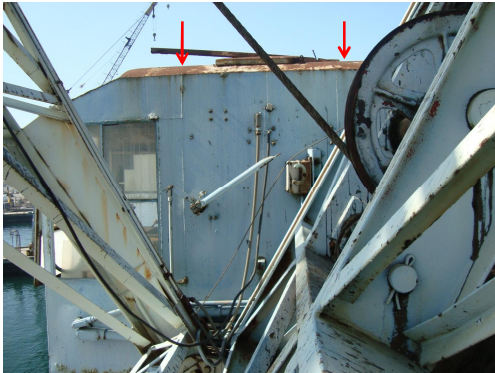
Observe the rust on the top of the operator's cab.

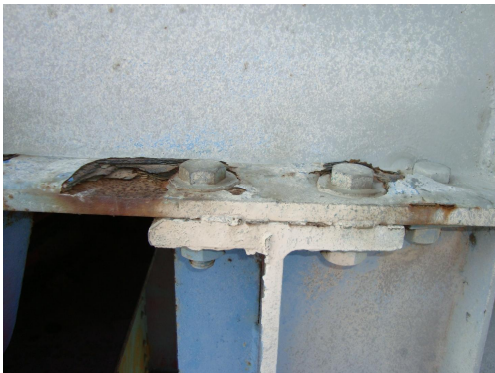
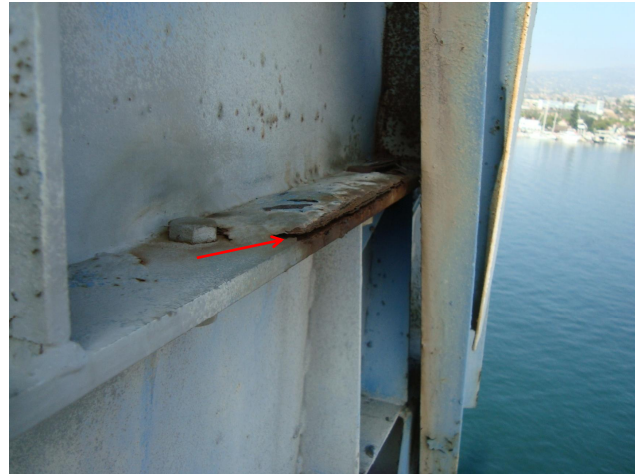
Please notice the de-lamination of the structural steel.
This occurs in multiple areas of the crane.

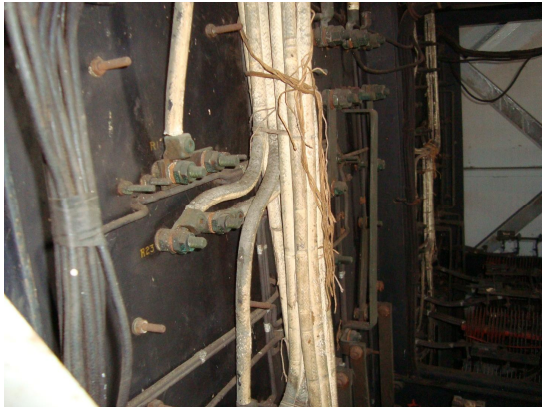
Please notice that these cables in the electrical panel are damaged and in need of repair.

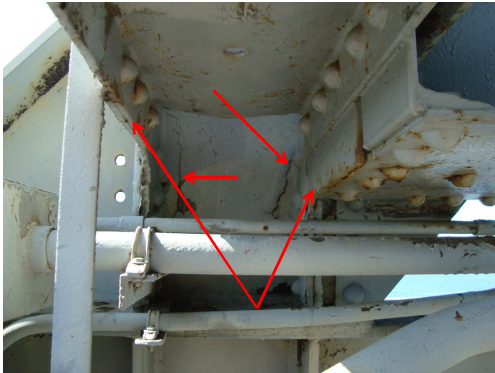
Please notice the de-lamination of the structural steel.
Also, the rust is bulging out and cracking the paint.

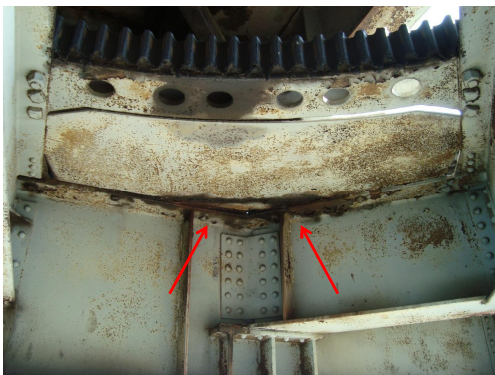
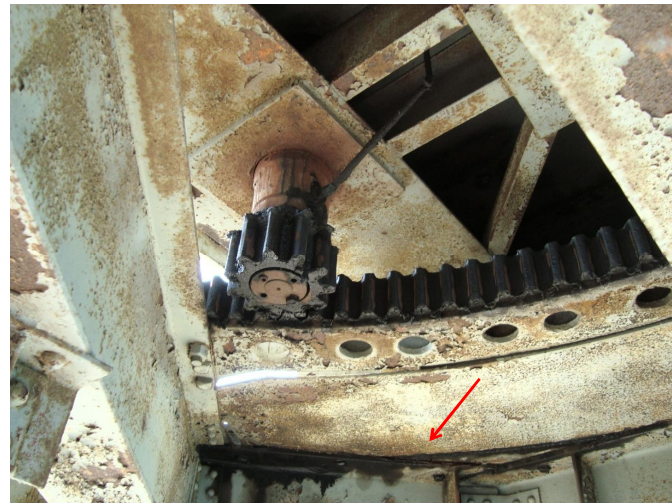
The platform of the Rotator gears is rusting and de-laminating underneath.

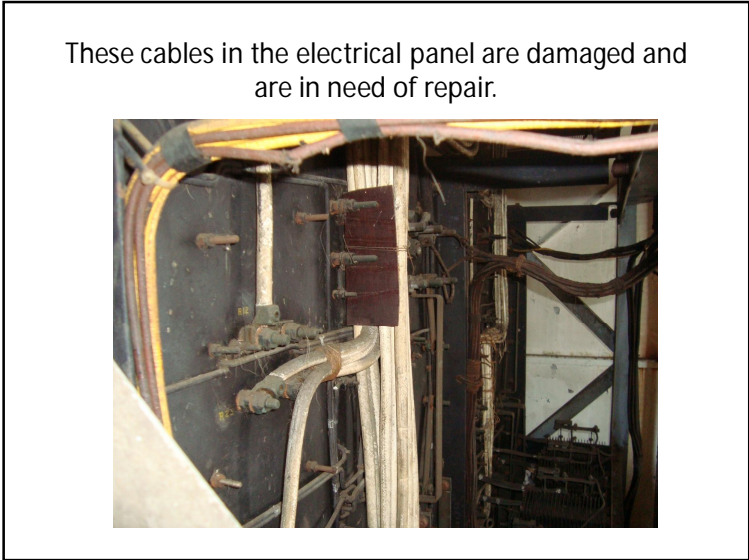
These cables in the electrical panel are damaged and are in need of repair.

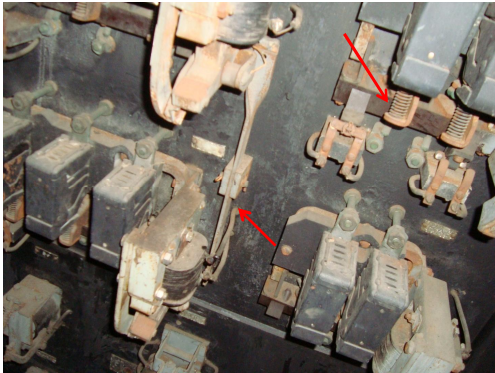
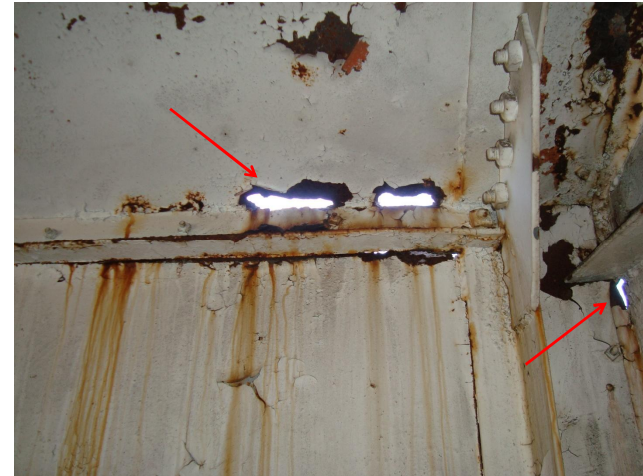
With all the corrosion of the components we believe it is not possible to get these panels functional.

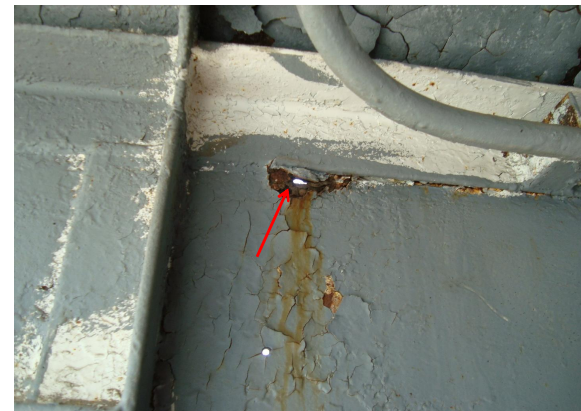
The structural integrity of the operator's cab is in question.

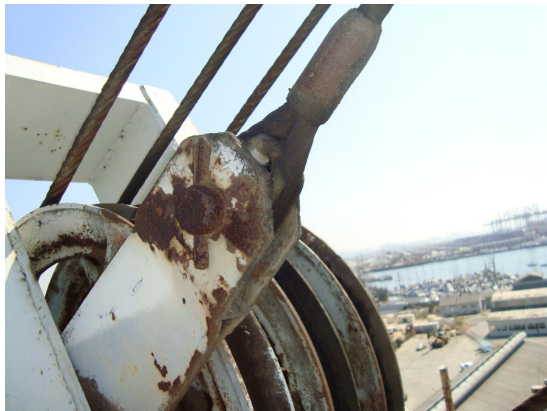
The boom sheave block is corroded and the bearings and sheaves are in question.

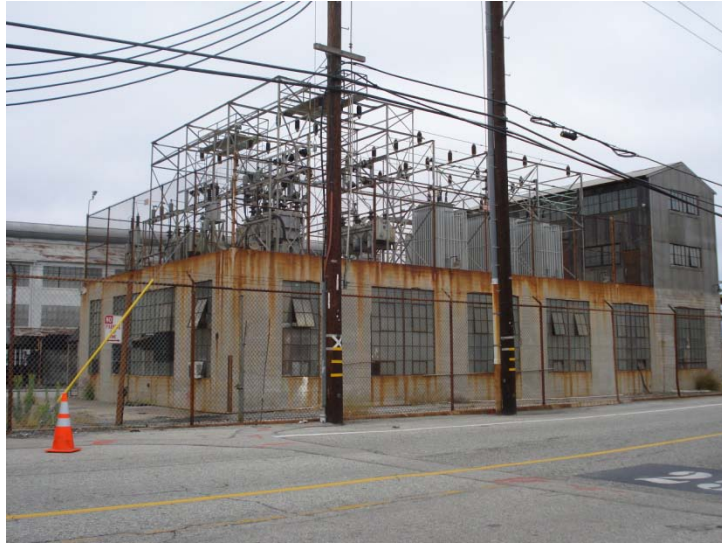
Figure 4

4. Until recently there were two incoming lines feeding into the substation. LADWP has removed one of the incoming lines and now the substation is fed only with one line. See Figure 4.

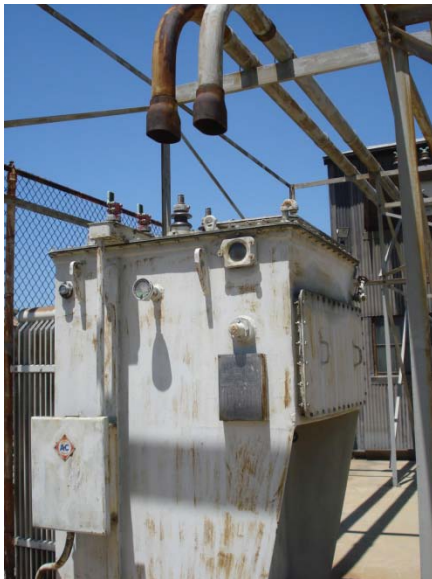
Figure 5

5. The substation was equipped with two transformer banks, one of which has been disconnected and wires are removed. The other bank still is connected. See Figures 5 and 6.

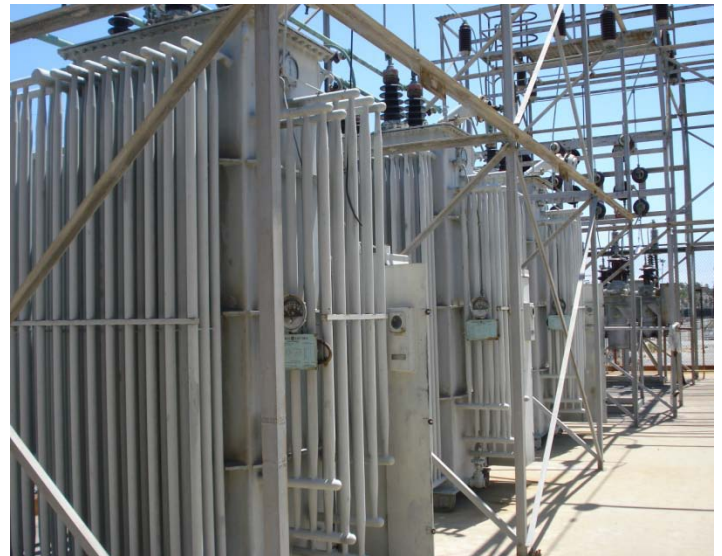
Figure 6

7. the original metering section connected via a taped live bus. See Figure 6.

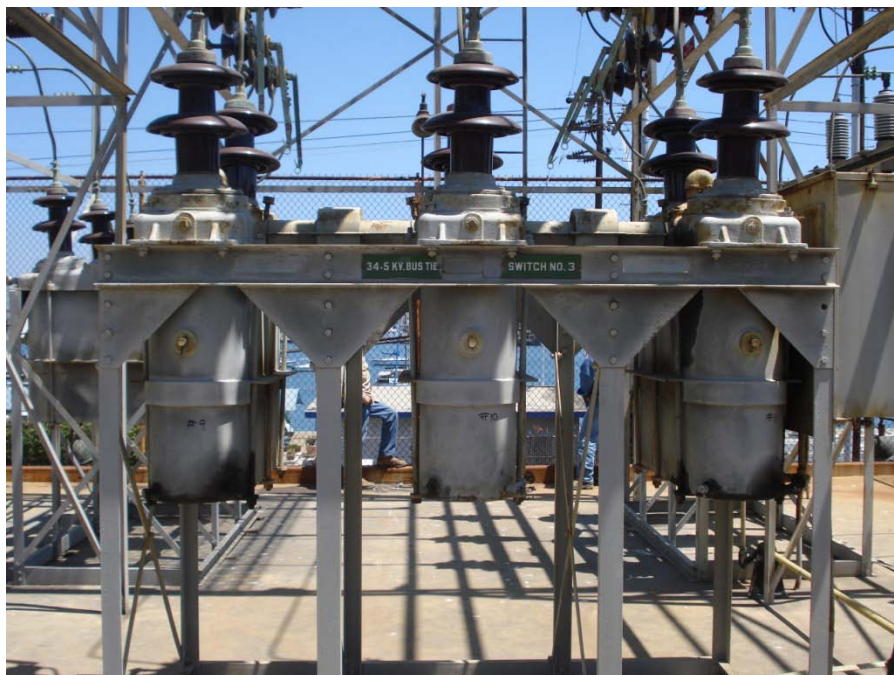
Figure 8

8. The LADWP metering design includes a compensating transformer which is no longer being used by LADWP, and is in the need of replacement.
9. The substation does not have a LADWP owned circuit breaker which in event of fault would enable LADWP to isolate their facilities from the customer equipment.
10. There are no fuses involved in the main feeders.
11. The existing circuit breakers are oil filled type and appear to be leaking. See Figure 8.

- e. Shall drain the oil from each oil filled equipment, including but not limited to the transformer coils, circuit breakers and other oil filled electrical components, clean the components, repair or replace the component if necessary, refill with new oil and recertify the equipment for its operation, protection and safety as intended by its original manufacturer.
