TRANSMITTAL #1

Subject: Parker Diving Services Does Not Qualify for the Port of Los Angeles Diving Services Contract Bid No. F-629

Re: Berth 73W Timber wharf and pile inspection.

Re: Berth 191 Timber wharf and pile inspection.

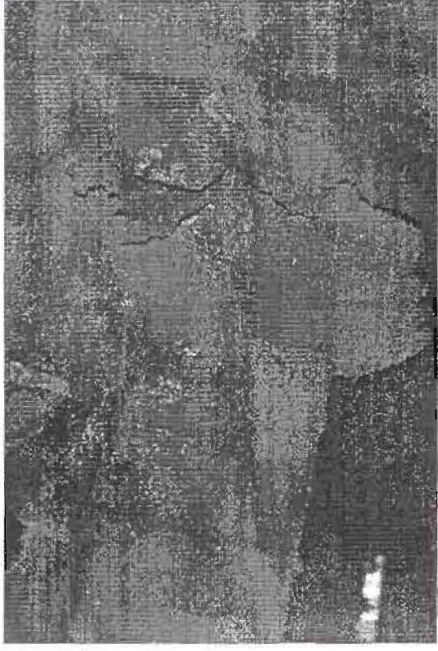
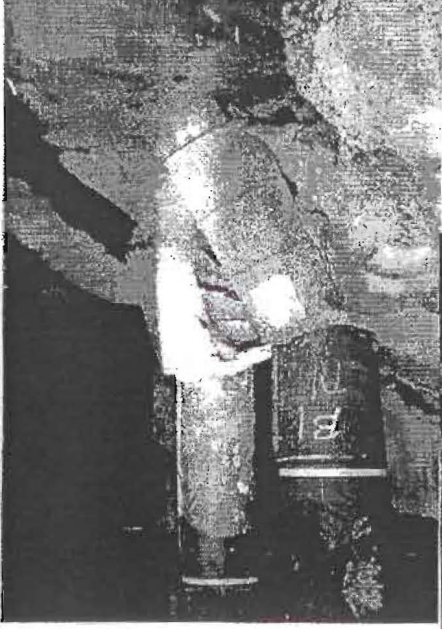
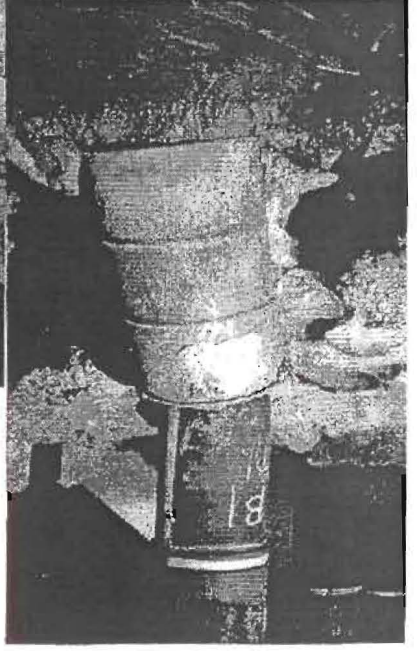
Exhibit C

asked to check all of diver Fenton's work and correct all of his deficiencies. Later on during that same contract period, numerous pile repairs conducted by Parker Diving at Berth 195 were found to have been done improperly. Further, half barrels were placed on rocks for forms with no footing dug for concrete placement; which obviously resulted in undermined and exposed pilings in less than a year's time, leaving the bare wood exposed to worm infestation necessitating eventual significant repair and/or replacement. (for pictures, see Exhibit C)

Parker's Previous Work
(year ≈ 2000)
