**WATERFRONT & COMMERCIAL REAL ESTATE DIVISION**  
**LOS ANGELES WAREHOUSE NO. 1**  
**REDEVELOPMENT AND ADAPTIVE RE-USE OPPORTUNITY**  
**REQUEST FOR INTEREST**

**DUE DILLIGENCE DOCUMENTS**

- 1) ARCHITECTURAL ELEVATION DRAWINGS**
- 2) PRELIMINARY GEOTECHNICAL INVESTIGATION WAREHOUSE NO. 1 SEISMIC RETROFIT**
- 3) STRUCTURAL FEASIBILITY STUDY**
- 4) HISTORIC RESOURCES EVALUATION REPORT**
- 5) REPORT OF FIELD INVESTIGATION AND MATERIALS TESTING**

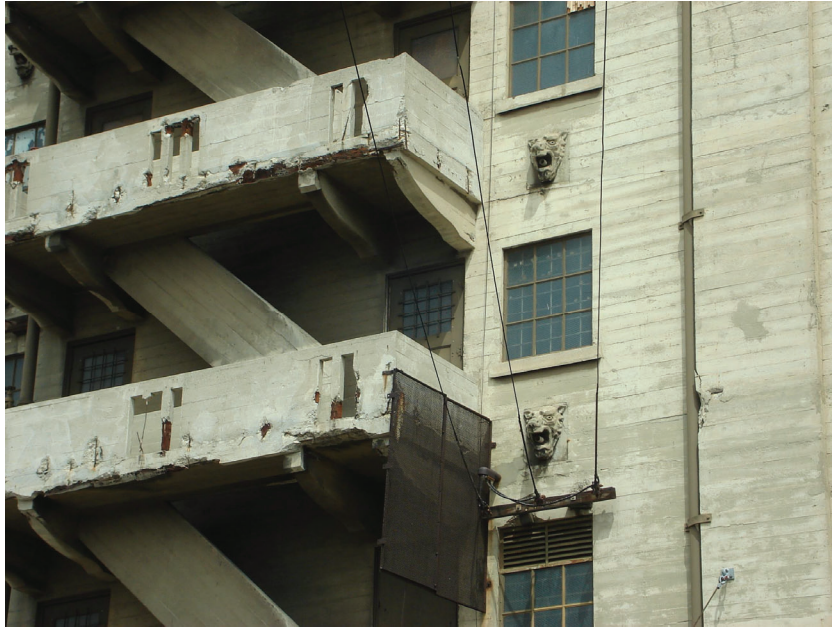
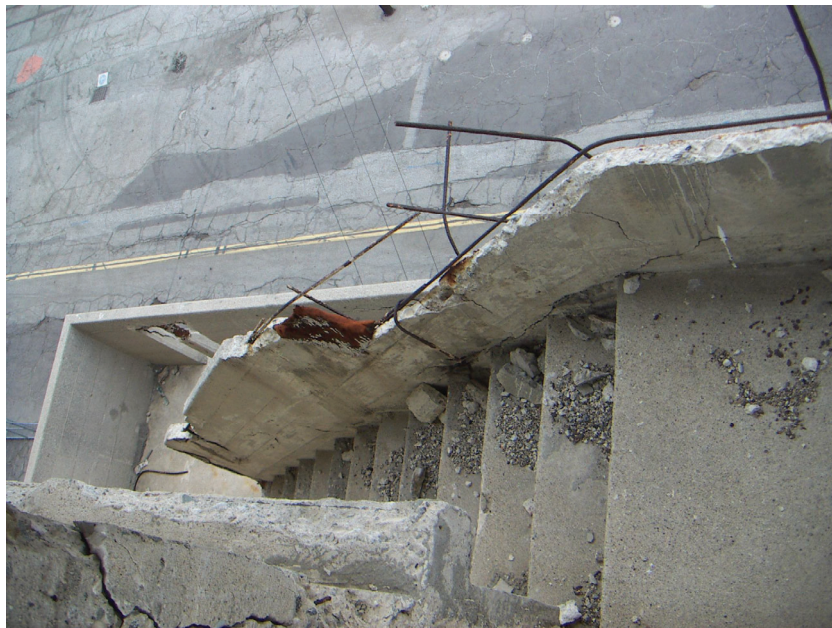
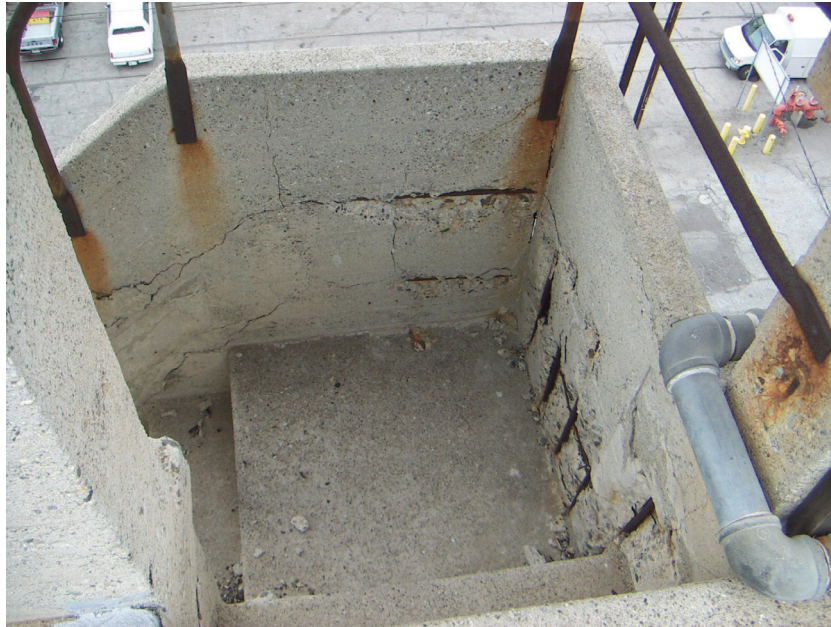
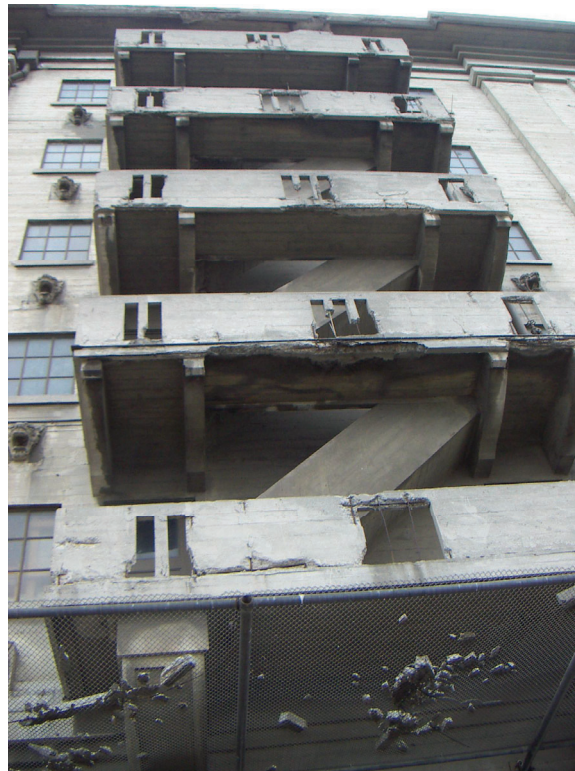
Figure 4 – Exterior Stair Deterioration

In general the rest of the exterior of the concrete walls are in good condition, with minor spalling at occasional locations with exposed and corroded reinforcement steel. A few architectural cornices are spalling from the building near the roof line, and at the parapet. A few locations of spalling were observed on the inside face of the roof parapet. This deterioration is not structurally significant, but a potential falling debris hazard exists.
