# LANDSCAPE INVENTORY

### Landscape Inventory for the San Pedro Waterfront Project

## Landscape Inventory San Pedro Waterfront Project

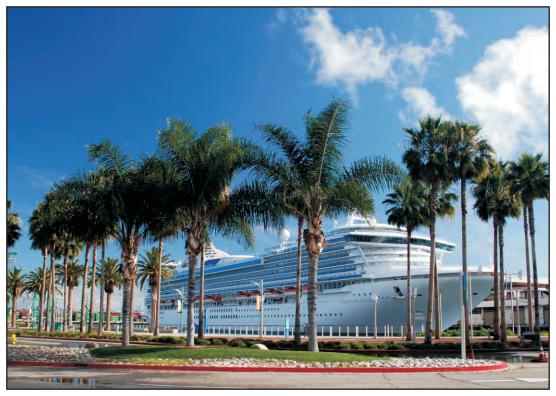
Photo 7 - Large Fan and Feather Palms Line the Cruise Ship Promenade  $\,$

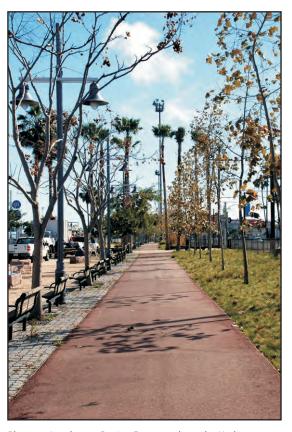
Photo 8 - Landscape Design Features along the Harbor Boulevard Parkway South of Fanfare Fountains

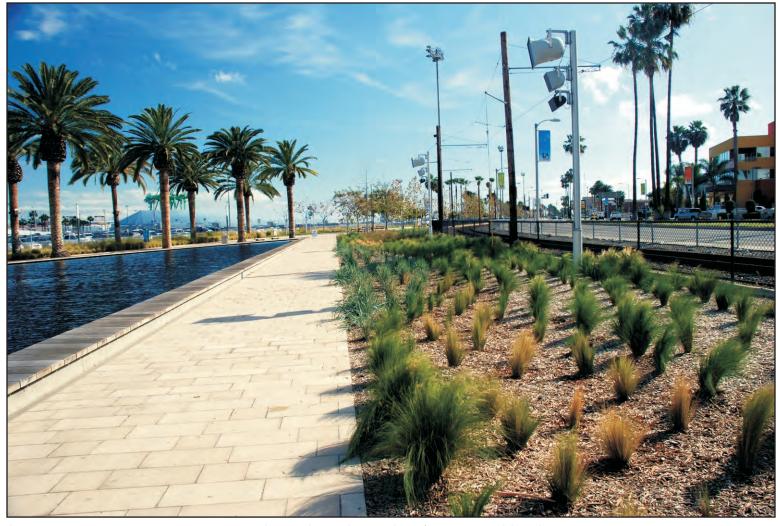
The completed portion of the promenade, from Swinford Street to the north of 5th Street, has a consistent, diversified, well-designed planting palette made up of large mature specimens that have given the newly constructed area a mature feel and has helped to create a sense of place. The dominant plant materials are a mature mixture of fan and feather palms that are normally planted in clusters or rows. Photograph 7 shows a planting area on Swinford Street. Portions of Harbor Boulevard Parkway Promenade are lined with London plain and golden rain trees, which create a pleasant canopy over the walkway. Photograph 8 shows this landscape treatment south of the Fanfare Fountains. Groundcover, mostly a variety of grasses, is planted along the promenade, but the majority of the area is covered with hardscape (Photograph 9). The majority of plantings along the completed portions of the promenade are low-water requirement species; mulch is used extensively to reduce evaporation and reclaimed water is used for irrigation.

Photo 9 - Water Conservation Design Features Incorporated into Landscaping between the Fanfare Fountains and the Red Car Line.

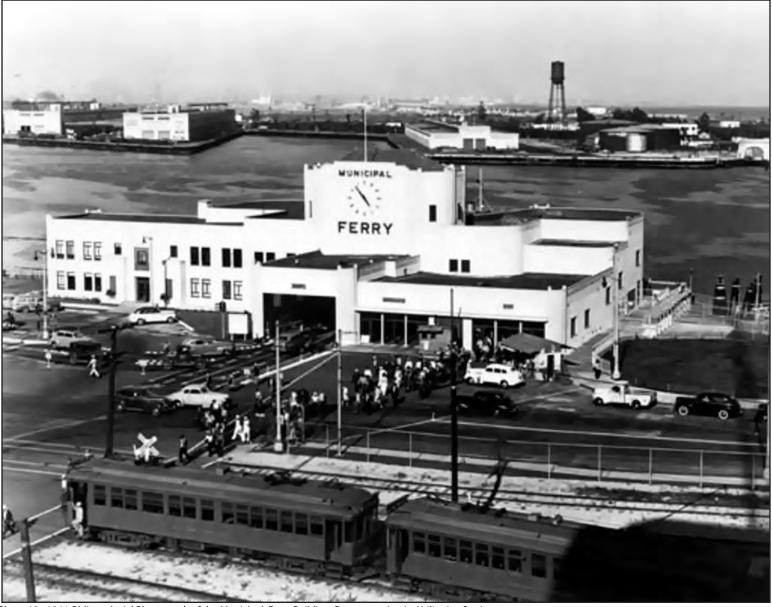
This landscape unit has historical context dating back to the construction of the Municipal Ferry Terminal in 1941, which was the building's first use. The Municipal Ferry Building was listed on the National Register of Historic Places (NRHP) in 1996 and was designated Los Angeles Historic-Cultural Monument No. 146 in 1975. The building and its surroundings have evolved over the life and uses of the structure. After ferry service was terminated due to the completion of the Vincent Thomas Bridge, the building became part of the Los Angeles Harbor Department's offices. The building was subsequently rehabilitated, and the ferry building is now home of the Los Angeles Maritime Museum. A review of historical photographs revealed an aerial view of the Municipal Ferry Building shortly after construction, and the building's perimeter appeared utilitarian and devoid of significant landscaping. Photograph 10 is an oblique aerial photograph of the structure and its surroundings as it appeared in 1944.

Photo 10 - 1944 Oblique Aerial Photograph of the Municipal Ferry Building, Demonstrating its Utilitarian Setting.
