**Engineering Evaluation
Of
Gambol Marine Shipyard
Proposed Business Plan**

Supplement to July 21, 2010 Report

October 21, 2010

**The Port of Los Angeles
425 South Palos Verdes Street
San Pedro, CA 90731**

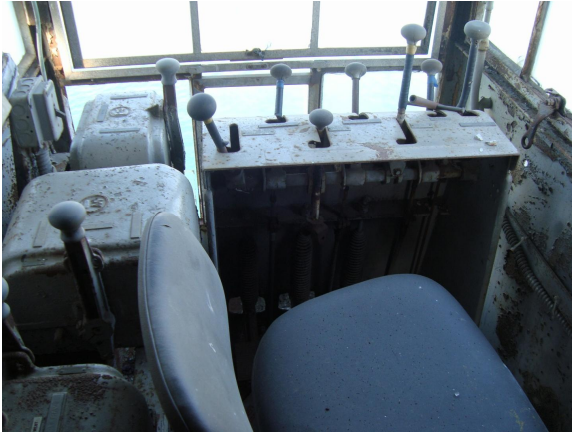
Operator's Cab Controls

Our concern here is the structural integrity of the cab housing.
Light is visible into the cab.

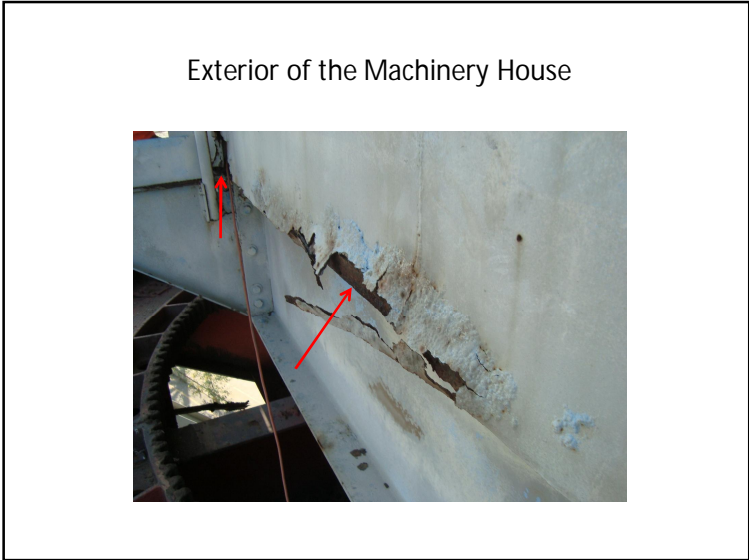
Please notice the extensive rust corrosion. The structural integrity of all of the components is in question.

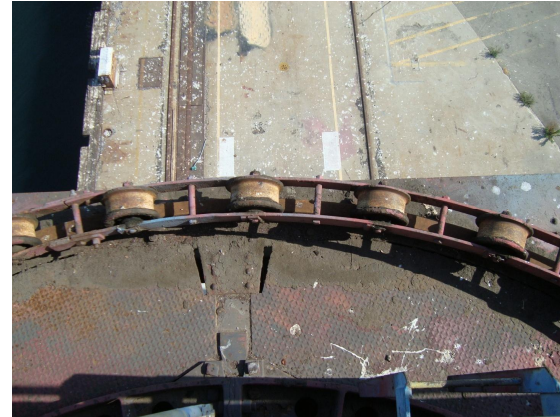
Rotating Wheel Assembly

Please notice the de-lamination of the structural steel.
This occurs in multiple areas of the crane.

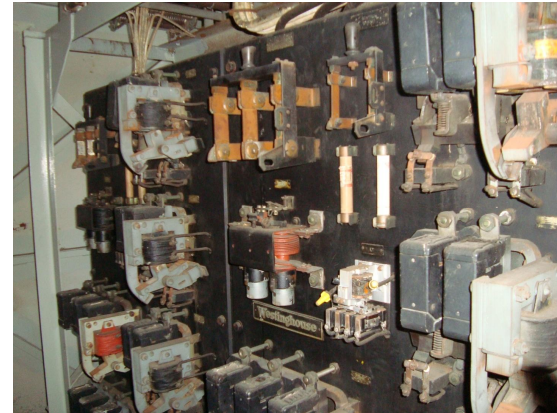
Electrical Panel

Please notice that these cables in the electrical panel are damaged and in need of repair.

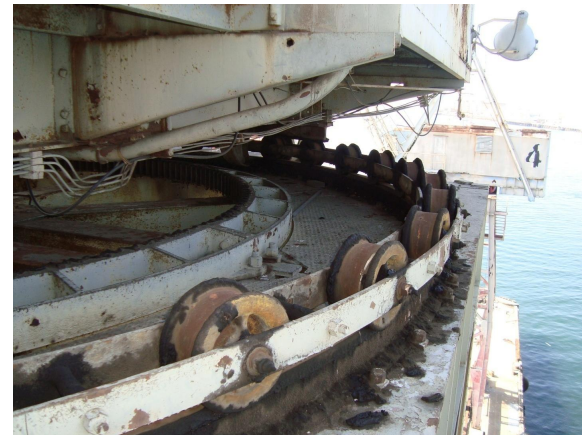
Rotating Wheel Assembly

Please notice the de-lamination of the structural steel.
Also, the rust is bulging out and cracking the paint.

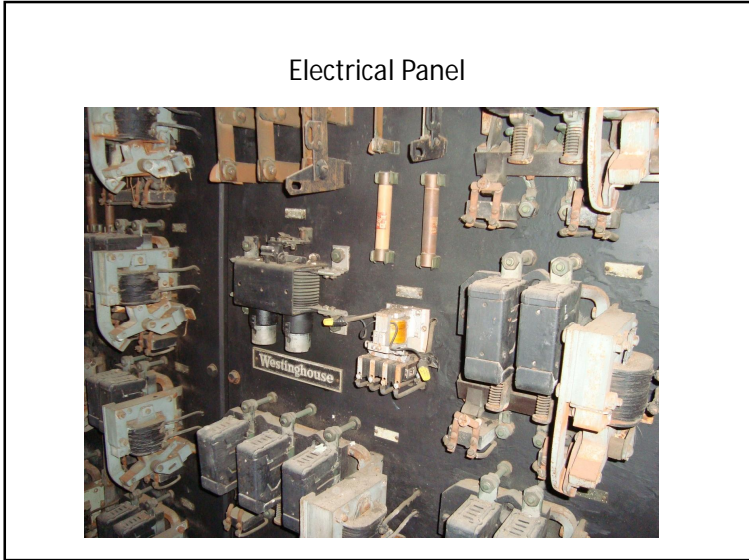
Electrical Panel

These cables in the electrical panel are damaged and are in need of repair.

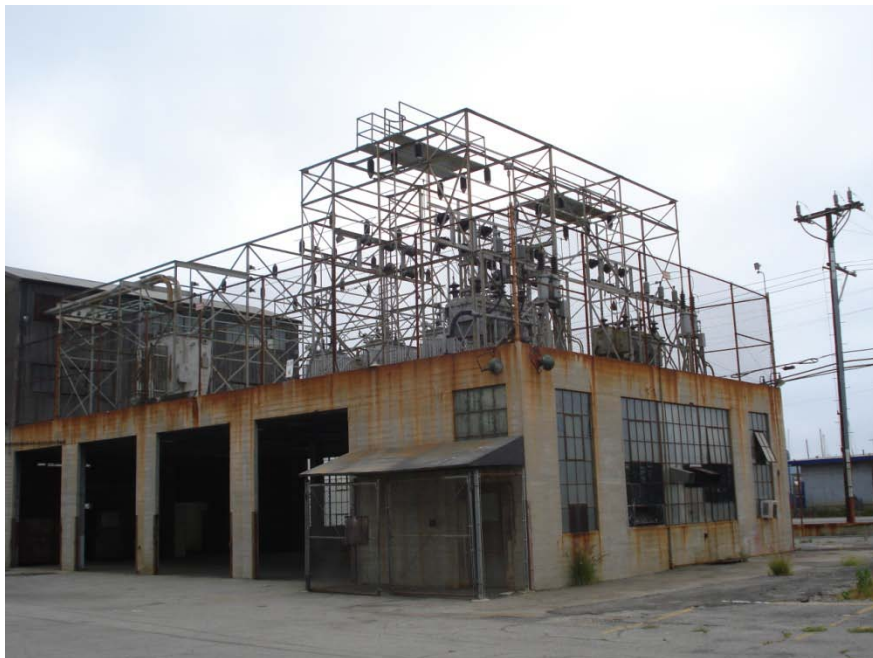
Figure 1

1. The station is owned by the customer (Port of Los Angeles). See Figure 1.

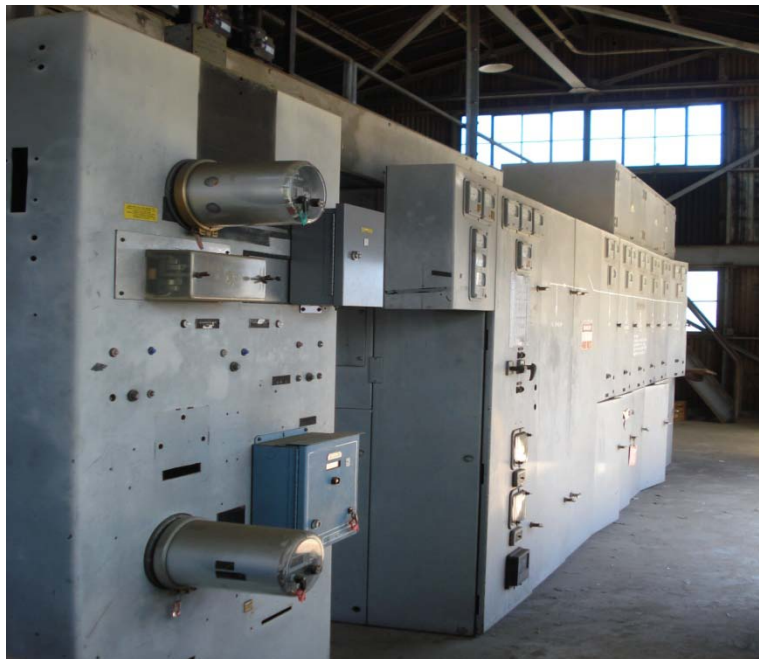
Figure 3

3. LADWP service enters at 34.5 kV and is metered at that level. The transformers, circuit breakers, and switchgear after the metering is the customer's property. See Figure 3.
