APPENDIX L
Water Quality

NPDES Discharge Permit Records

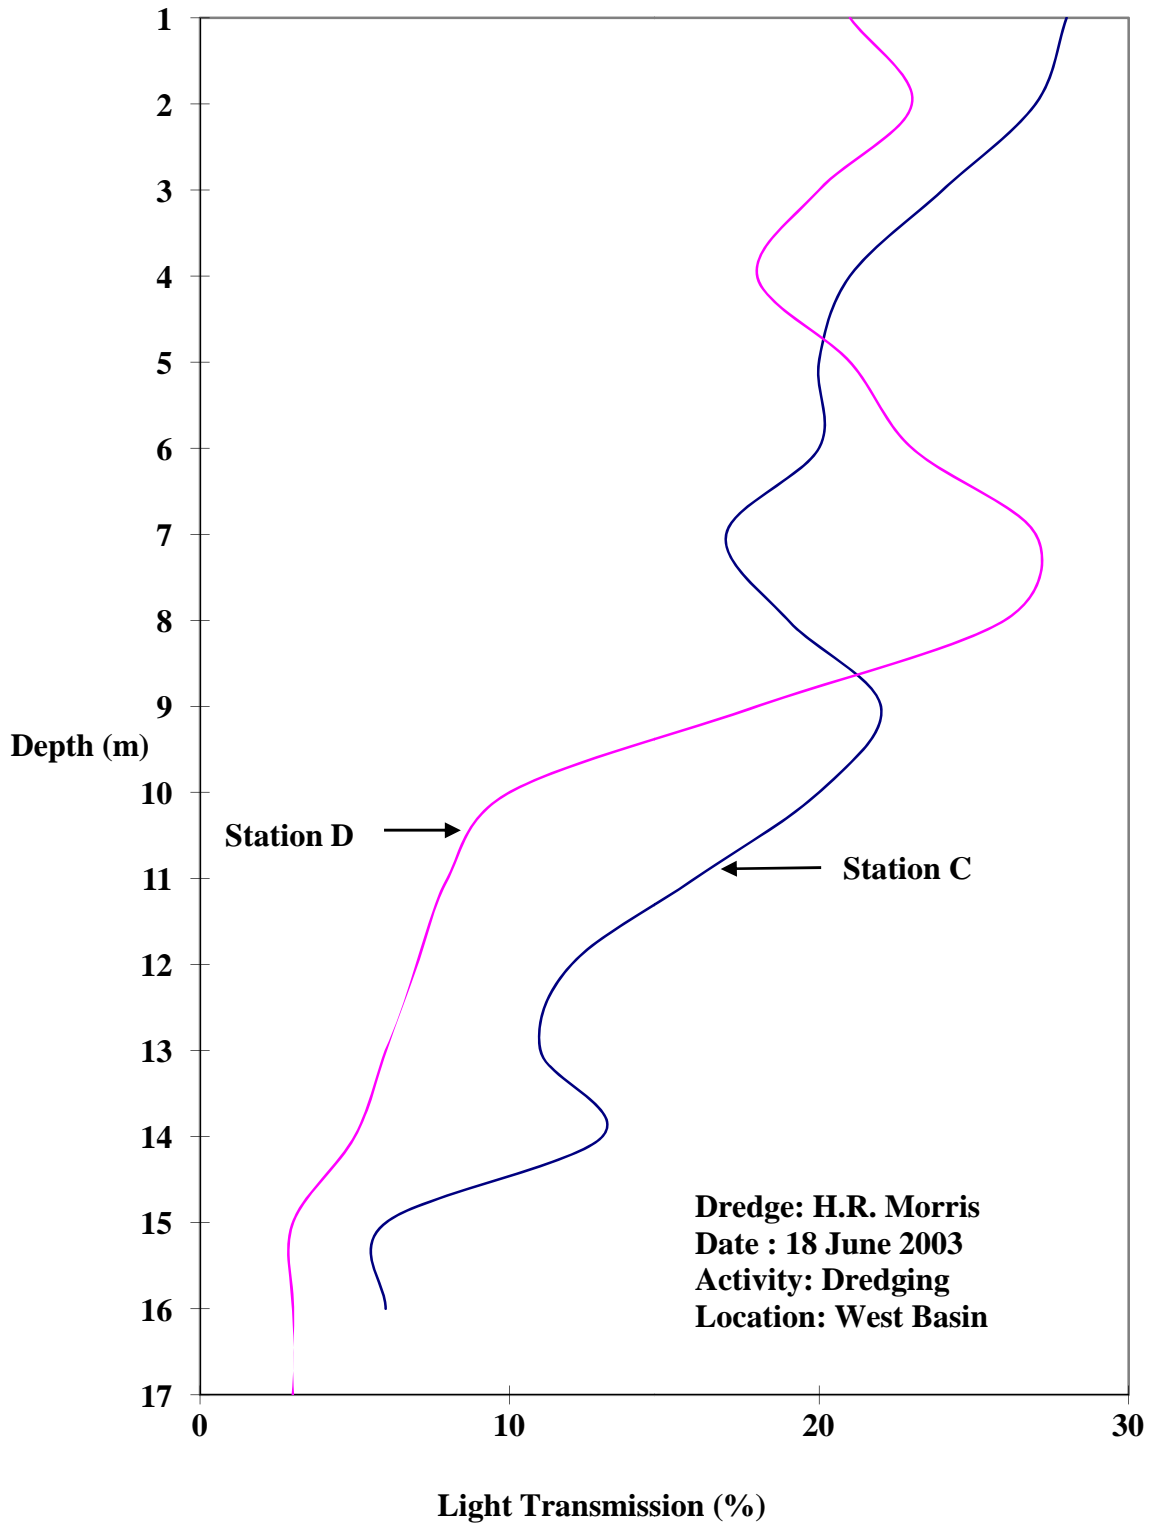
Light Transmission at Suction Dredge

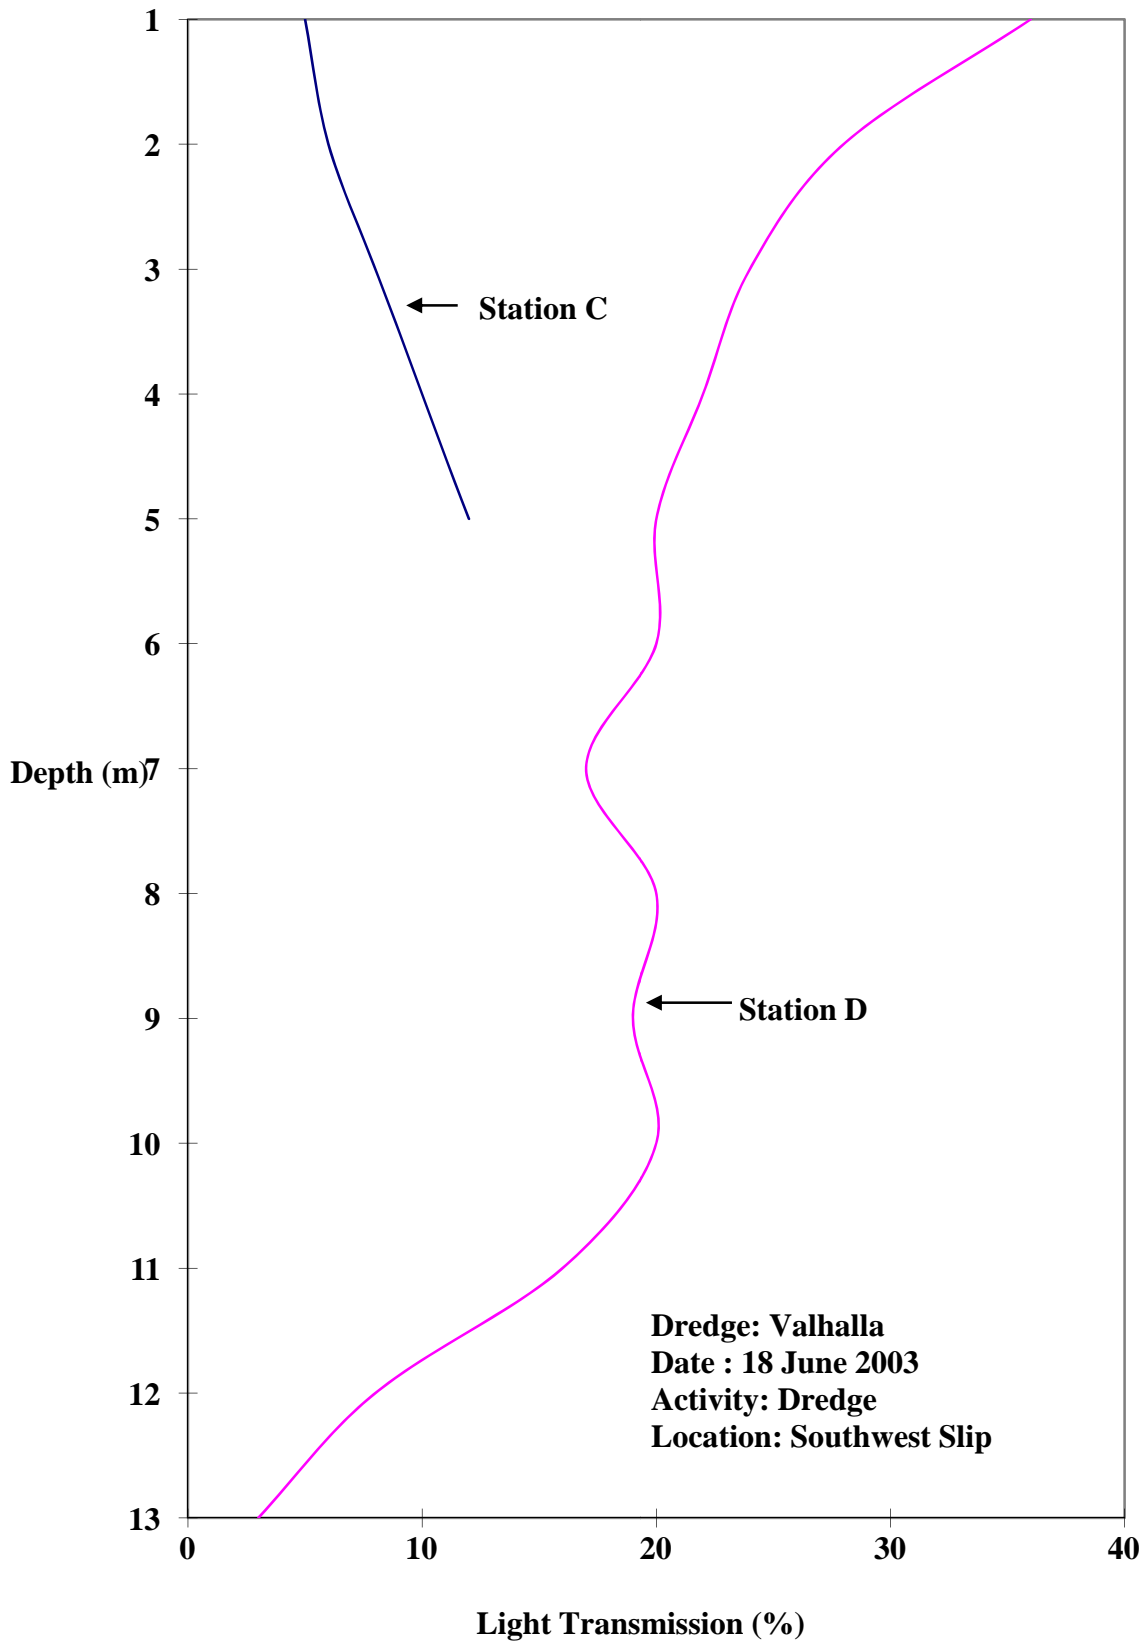
Light Transmission at Clamshell Dredge

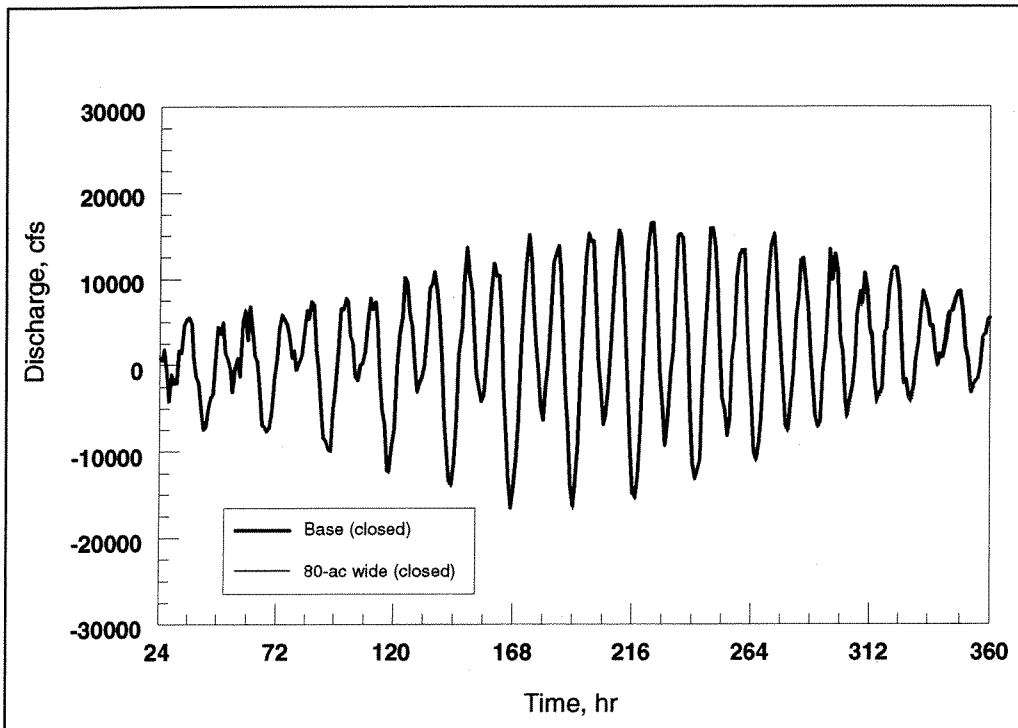
Figure 5. Comparison of discharge time-series for base and 80-ac wide configuration at transect 4 (closed gap).

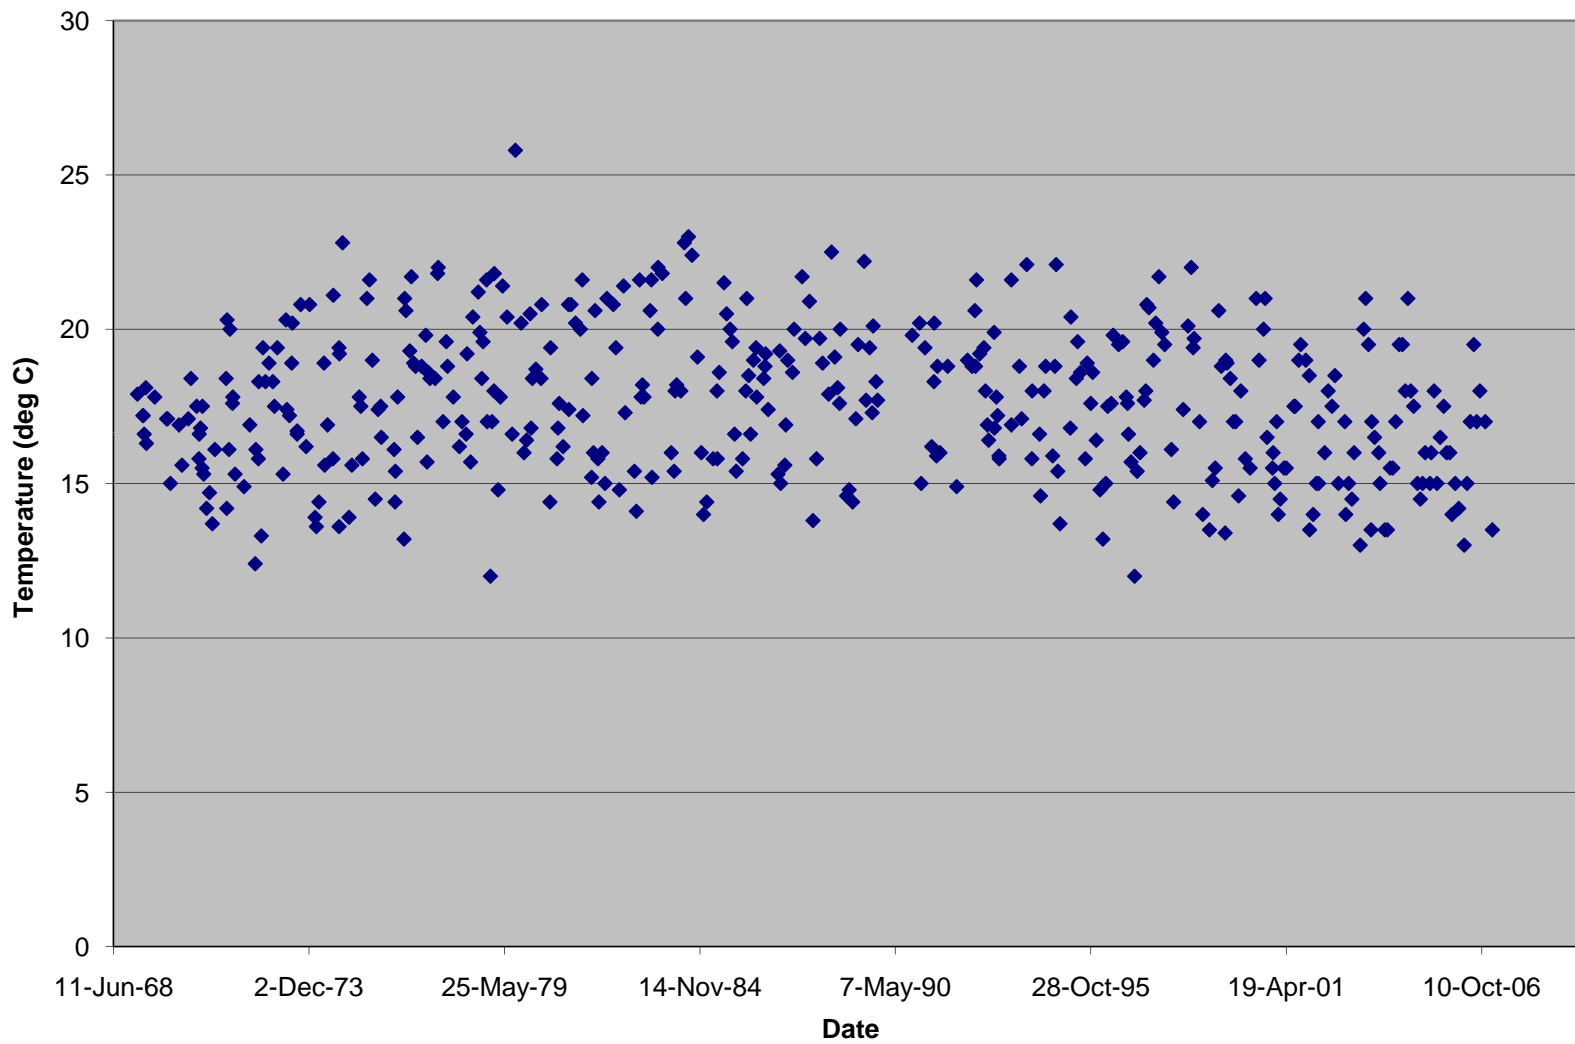
LA-35 Temperature
